The 1825 Stockton & Darlington Railway: Historic Environment Audit

Appendix 1. Witton Park to St Helen Auckland.

October 2016 (2019 revision)

Archaeo-Environment for Durham
County Council, Darlington
Borough Council and Stockton
Council.

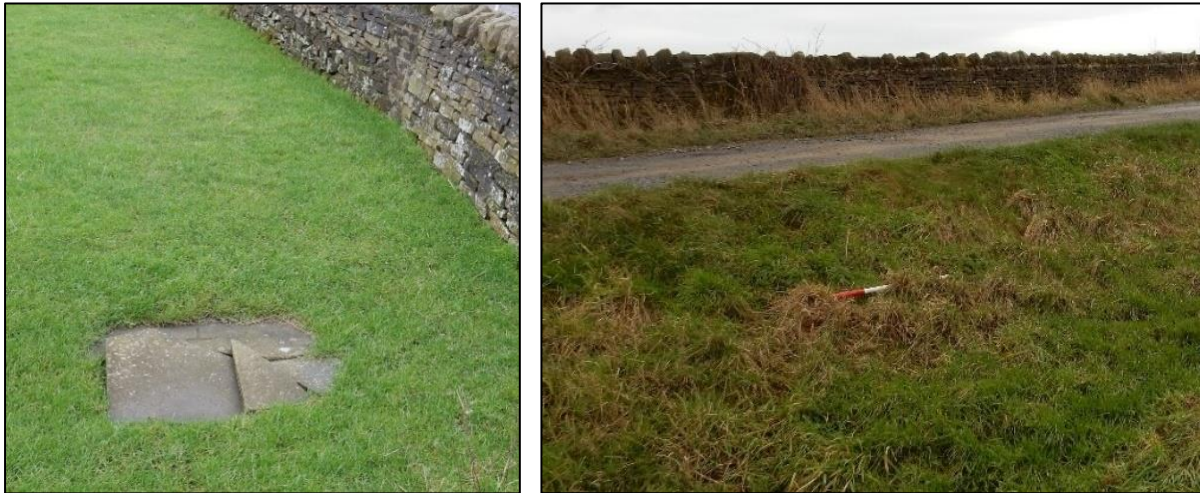
Plate 1. Left: the well shown on the 1855 OS map. Right: the line of the 1825 track from William Pit.

The fields to the east of the modern track have been subject to open cast mining according to the Coal Authority records, but in the NW corner of the field, a well shown on OS maps dating to 1855 (1st ed) appears to have survived (SDR504). It is marked with some flat slabs with the letter T on one of them. This is a reminder that while fields were surface mined, remains can survive around field edges, under the site of bunds and former offices.

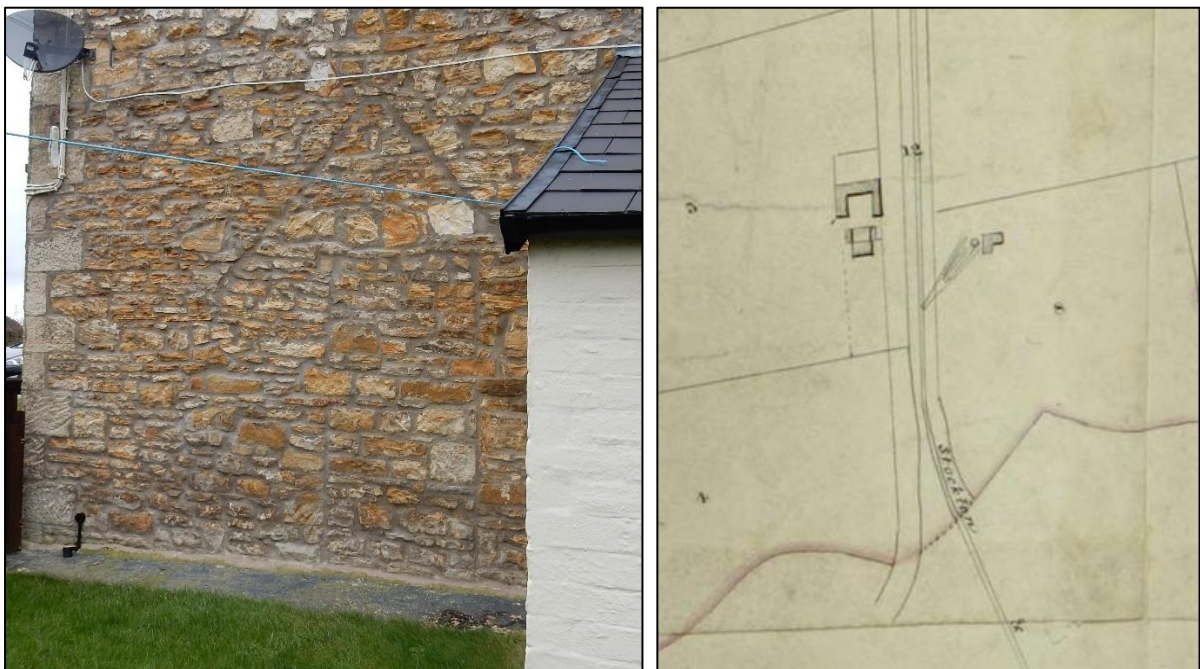
Plate 2. (left) Site of the pay office to use the incline, as shown on the gable end of no. 1 Phoenix Row. (right) The Tithe plan of 1839, prior to the building of the terrace of miners' housing and showing a colliery or sidings on the east side of the S&DR line.

No.1 Phoenix Row (NZ1677 29188) has the scarring of former buildings on its south gable end and contains reused two-hole sleeper blocks within its fabric. Local knowledge suggests that one of these former buildings was the pay office or weigh house (SDR51) where waggons of coal were weighed and tickets purchased to use the Incline. There are no buildings shown on the 1839 tithe plan however, but there must have been a facility for weighing and paying. This area is of considerable significance therefore because this suggests that this was the hitch up point where waggons were transferred from horse power to steam engine powered rope incline.

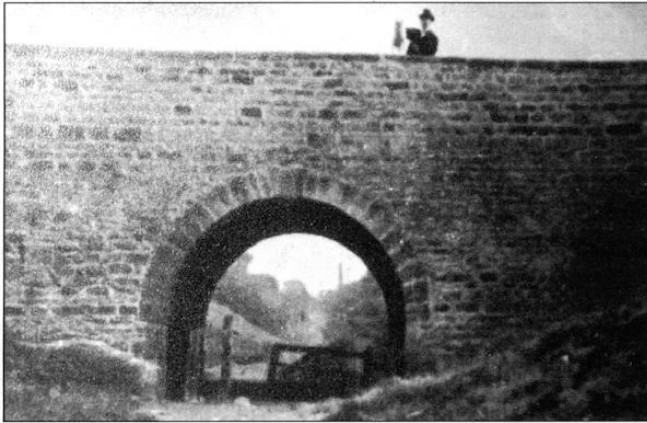
Plate 4. (left) East facing culvert entrance under the North Etherley Incline.

The culvert beneath the north incline, just south of Phoenix Row (SDR44), is in relatively good condition on the west side, but the east side has a slipped keystone which needs resetting.

Both culverts require vegetation clearance to protect them from root damage and to allow better inspections for maintenance in the future.
-

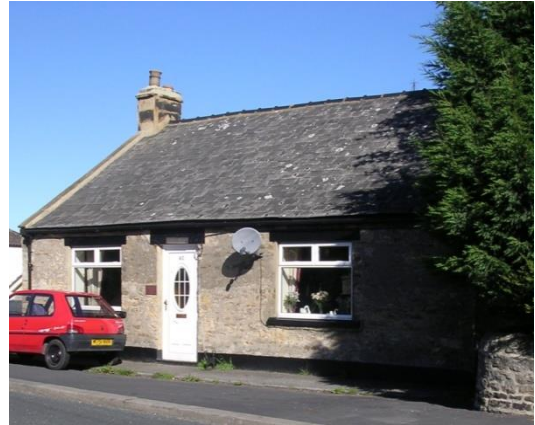
Plate 5. (Left): The lost road bridge at Etherley and, (right), the former Railway Inn adjacent

Part of the incline has been built over at Low Etherley and the bridge (SDR32) which carried the road over the incline at Low Etherley has been removed, although it is not clear if it was wholly demolished or buried.

The former Railway Bridge Inn should be made a building of local interest and identified as such in any future local plan documents.
-

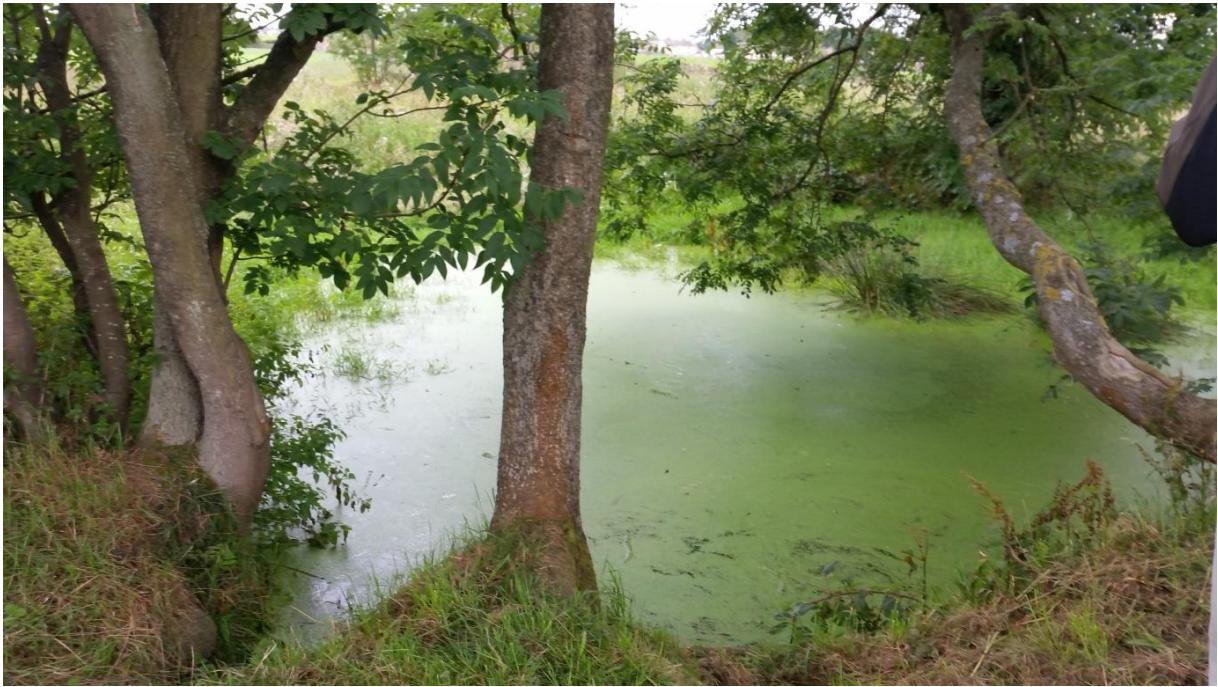
Plate 8. The remains of one of the reservoirs that fed water to the Etherley Engine House

The two reservoirs that fed the Engine House survive (SDR27 & 28), although only one now holds water. The culverted stream which supplies them still runs along a hedgeline to the west from a spring and should be considered as part of the monument (SDR25). Before reaching Greenfield Road, a good quality stone culvert runs under the incline carrying a small beck.

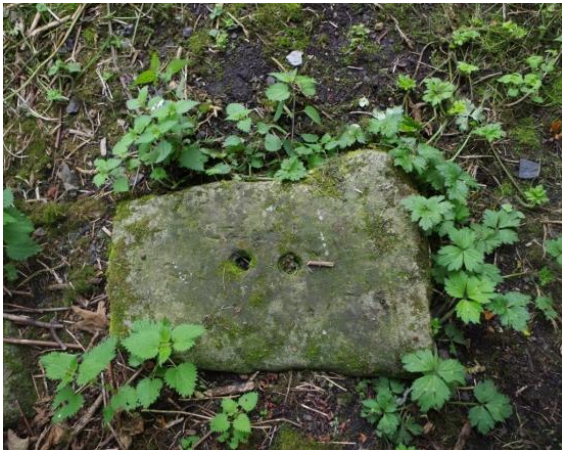
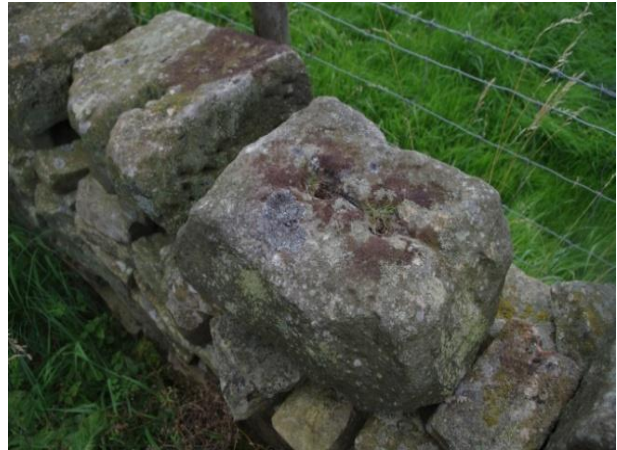
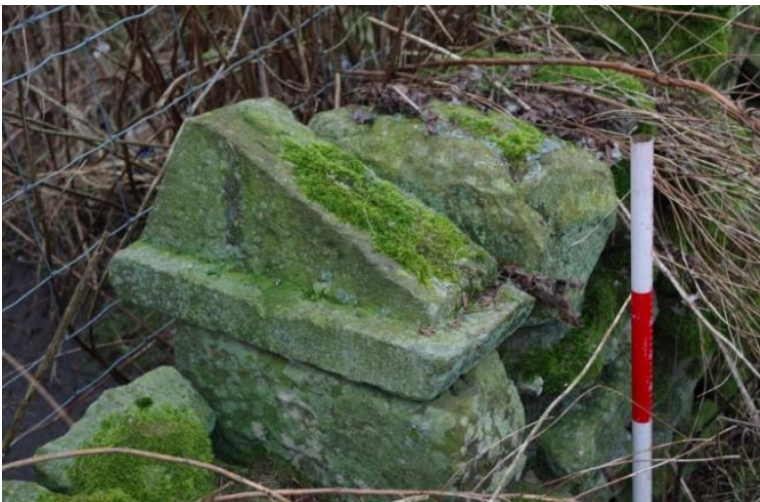
Plate 9. (above left) A two-hole stone sleeper from Etherley Incline and (above right) another incorporated into a dry stone wall near the site of the Engine House. Several architectural fragments from the now demolished engine house and cottages are present on site and re-used in boundary walls (below left).

Stone sleepers that have fallen down the side of the embankment, or are located in watercourses or are not earth fast, but are still visible, should be recorded in position, numbered and stored in a depot until provision can be made to securely reset them near where they were found.

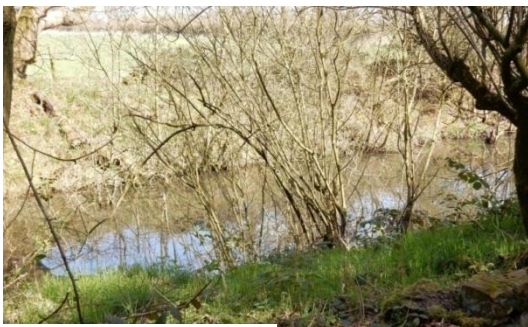
Plate 11. (Left). The flooded cutting with boundary walls at ground height in the foreground (looking south-east).

This has formed a substantial pond which keeps growing as more water fills the cutting. The original line of the east side of the incline is still visible in the adjacent field. Mapping from Historic England suggests the damaged side is however still scheduled.

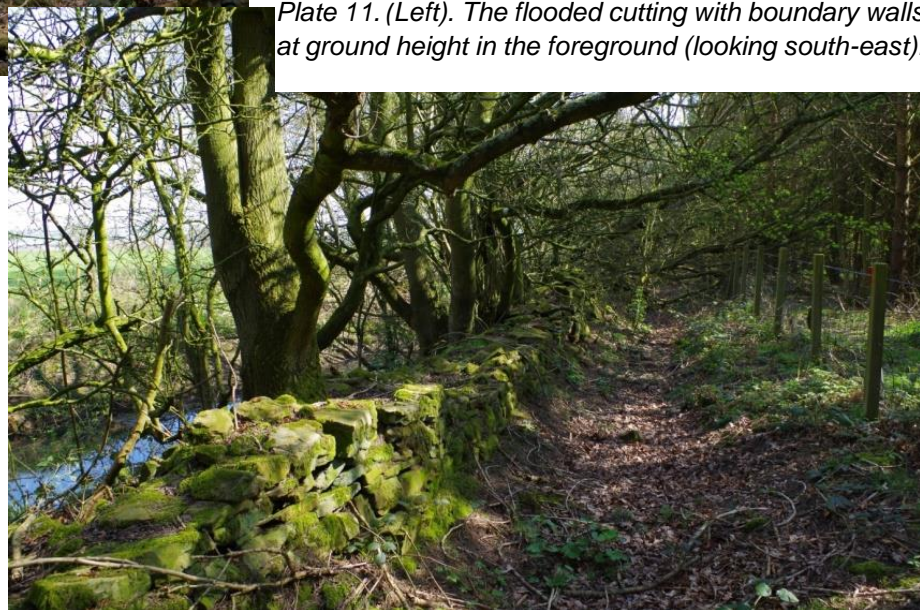
Plate 12. (Below). Looking south at the west boundary wall and external drainage ditch of 1825. The flooded cutting can be seen to the far right.

Where the line is in a cutting there is a ditch on the west side outside the boundary walls which runs along the top edge. Such an external ditch appears to be standard practice along much of the line. There was presumably a similar ditch on the east side but access was not possible to check.

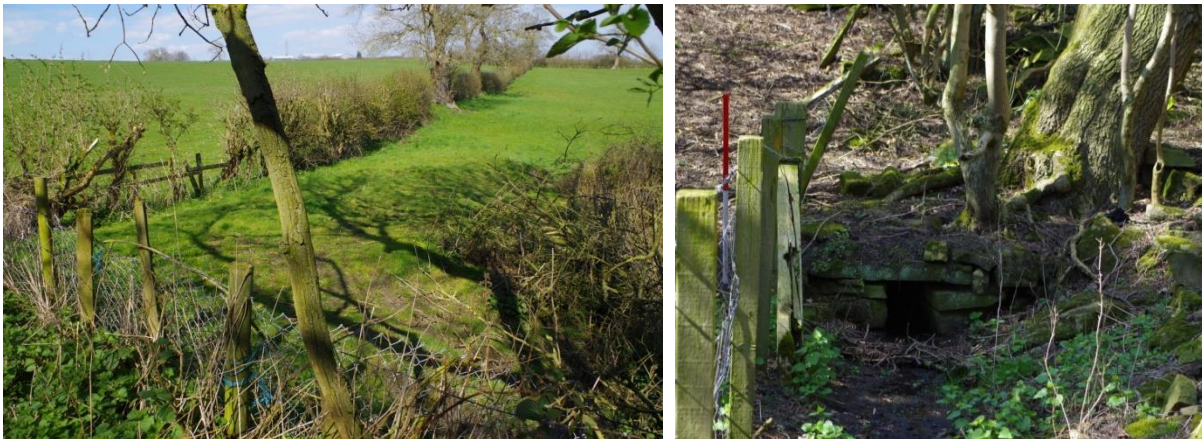
Plate 14. The incline has a crossing point consisting of metalled earth ramps to east (above left) and west. The drainage ditches of the incline run beneath the ramp in stone culverts (above right)

Where the incline is an embankment there was a crossing point which still survives (SDR 76). This approached the embankment via a ramp on both sides. The surface was metalled with small cobbled stones. A small simple culvert (SDR 75) ran below the ramp to carry a drain or watercourse alongside the embankment. At the point where the ramp met the incline track, two wooden gateposts still survive; one of them has a series of holes which could suggest that it was a reused wooden sleeper.

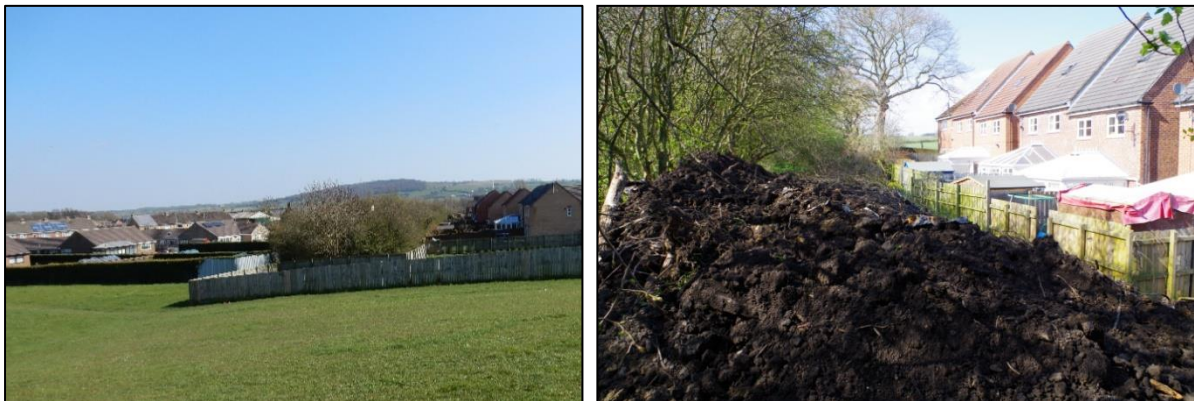
Plate 15. (Above left), The wooden fencing has enclosed part of the scheduled incline which belongs to DCC. The gap left follows the rest of the incline, but is blocked by undergrowth and fly-tipping. (Above right), immediately north further encroachment to the scheduled monument is taking place.

- 🏠 House owners are encroaching on to the scheduled area which belongs to DCC and which has been left as un-managed open space. This encroachment has been reported in the past ten years but appears not to have been fully resolved.
- 🏠 Encroachment may be less of an issue if the open space is better managed so that it does not attract anti-social behaviour. This is now an urgent matter as the space is visually unattractive and invites fly tipping. As DCC owned land, there are no issues of requiring owner consent.
- 🏠 The waste ground at Northbridge affords an opportunity for community excavation and subsequent landscaping. This may need adopting by local groups to help maintain it and to police encroachment.

- The encroachments currently taking place to the scheduled monument should be stopped and reversed. Failure to enforce the law and the Council's legal ownership is likely to result in additional damage and encroachment in the future. Local police and home owners should be informed about the legal status of the Etherley Incline and the police advised on procedures to use if prosecution is to be carried out.

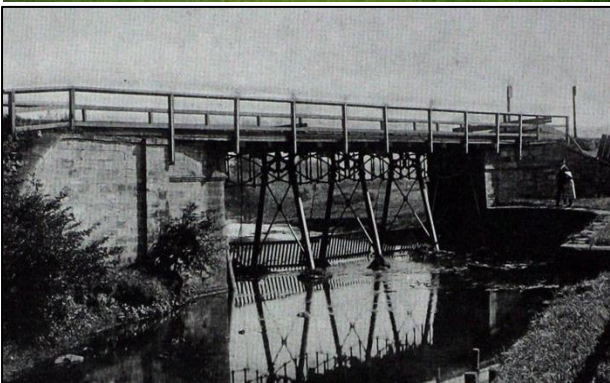
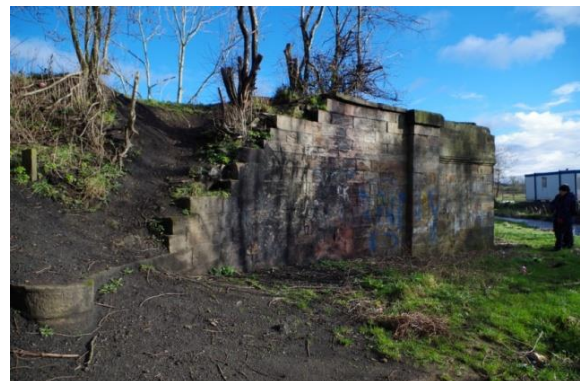
Plate 20. (below) The Gaunless Bridge looking south-east. Prior to 1901 (bottom left), and today (bottom right), partially dismantled, vandalised and covered in graffiti. This is a Scheduled Monument and one of the most important early buildings in railway history.

In late 2015 following a change in landownership on the south east side of the river crossing, part of the embankment and one side of the remaining accommodation arch was partially demolished despite being protected by designation as a scheduled monument. A condition survey and restoration report was commissioned by DCC from Blakett-Ord Conservation Engineering. At the time of writing repairs were still awaited.

The south abutment of the Gaunless bridge is suffering from self-seeded vegetation which needs to be controlled. The un-managed bushes hide the ornate stonework of the bridge abutment and its sweeping wing wall with string coursing and rounded pillar terminus so that it cannot be appreciated and the self-seeded trees on top of the abutment will be causing root damage. Self-seeded vegetation also disconnects the visual links between the bridge abutments and the accommodation bridge.
-

The recommendations of the Blakett-Ord (2015) report should be implemented.
-

The iron structure from the Gaunless Bridge should be moved from NRM York to NRM Locomotion at Shildon for display. The bridge was designed to be free standing which might make it easier to display. It should not be replaced on the abutments as it would be at risk from vandalism and the abutments were modified in 1901 so the original decking would no longer fit.
