The 1825 Stockton & Darlington Railway: Historic Environment Audit

Appendix 2. West Auckland to Shildon.

October 2016 (2019 revision)

Archaeo-Environment for Durham
County Council, Darlington
Borough Council and Stockton
Council.

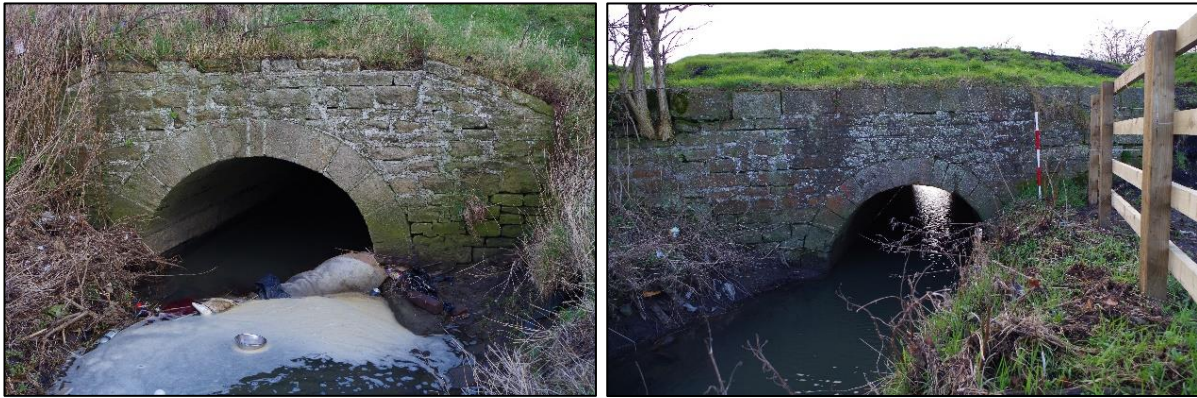
This stretch is mainly embankment with stone boundary walls, two culverts, a footbridge and a level crossing. About 80m south of the Gaunless Bridge abutments there is a small beck, Oakley Beck, which runs below the embankment and this is carried by a stone S&DR culvert (SDR87). On the south side there are two metal hooks and a chain above the arch suggesting a metal gate was previously hung from them to prevent stock wandering through the culvert.

Plate 1. Original 1825 culvert; viewed from below the railway embankment on the south side (left) and the north side (right)

A young tree is growing out of the north side of the Oakley Beck culvert and needs removing.
-

There are a few courses missing from the top of the Oakley Beck culvert on the south side but it appears stable.
-

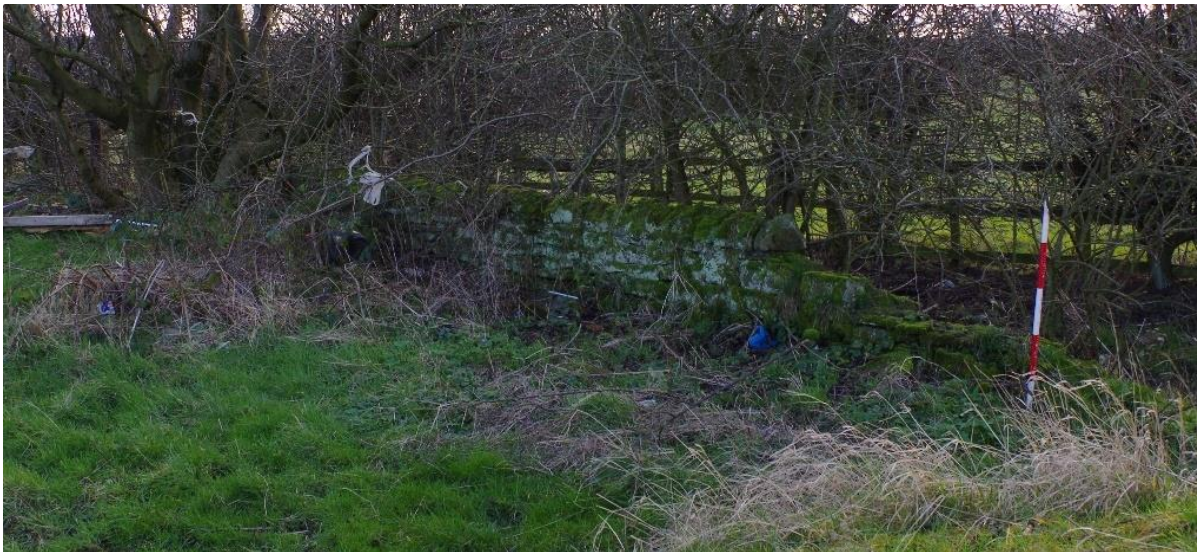
Plate 2. Stretch of stone boundary wall surviving

There are intermittent stretches of stone boundary walls along both sides of the embankment. There is about 2.24km of stone walling surviving (both sides), but much of this is at ground level having been robbed out. Some survive to their full height about 7-8 courses high with triangular copes on top. As the embankment increases in height the boundary walls are to be found at the foot of the slope.

It may be appropriate to repair some stretches of boundary wall where survival is reasonably good and where good stretches can be joined together and accept the loss of those parts that have reduced to ground level over long stretches. Some walling has hawthorn trees growing out of it. Where the roots are damaging reasonably intact stretches of walling, the trees should be removed.
-

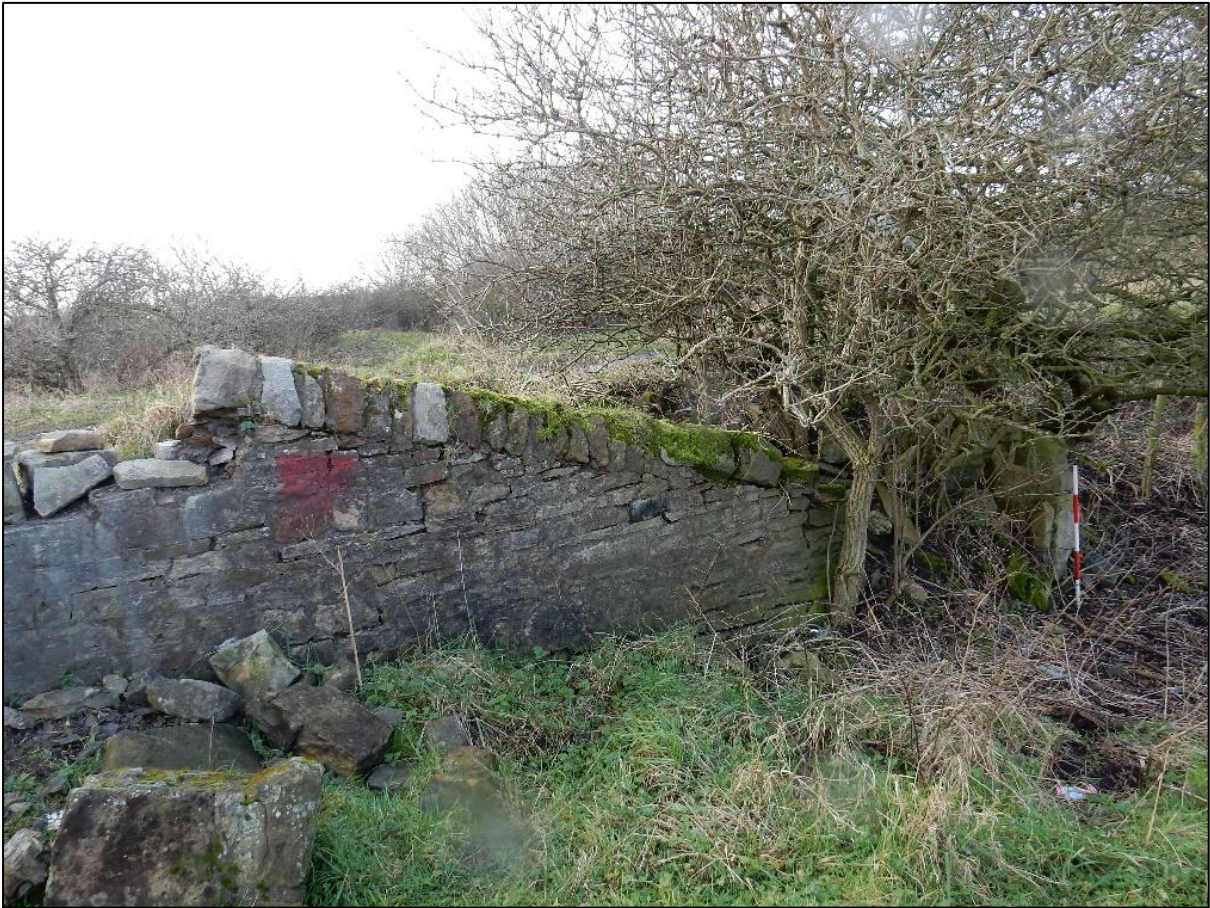
On the north side there is a stretch of walling that slopes. This sloping walling is used where the walls are abutting another structure. In this instance, there is an historic footpath to the south between two hawthorn trees as can be evidenced by the presence of two gateposts in the field. This appears to have been a crossing point from West Auckland to a fording point in the river and the construction of the railway would have obstructed it. Therefore, a small pedestrian accommodation bridge was provided which is now buried (SDR78). This can be

Plate 3. Sloping boundary wall indicating an adjacent structure – in this case a long forgotten and buried accommodation bridge and ramp

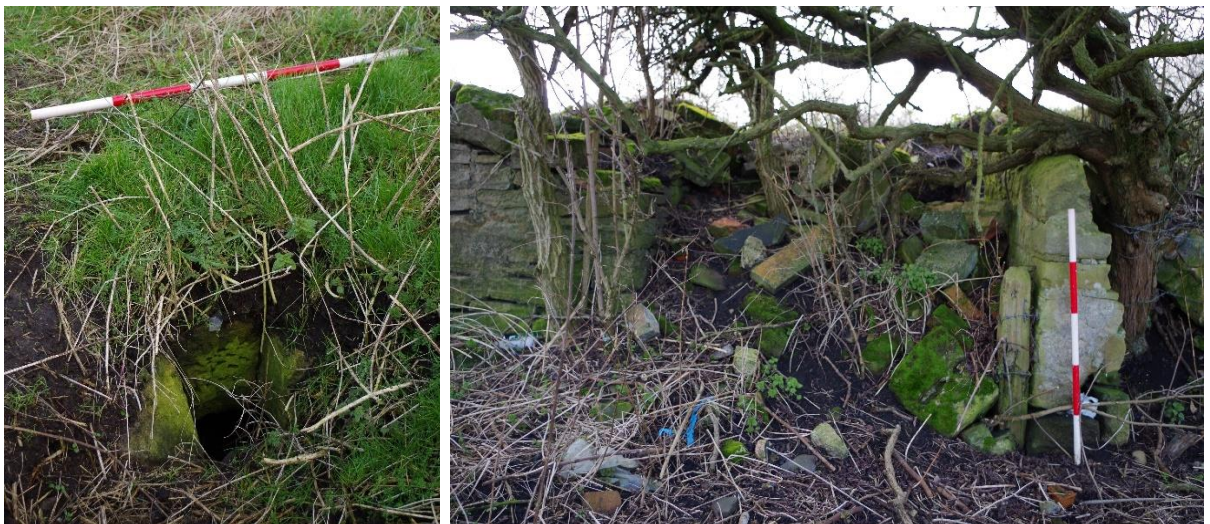
seen in the embankment on the south side where there is a small hole where the remains of the passage or tunnel can be seen. Only the top of the arch is visible in the hole and it is clear that the keystone has slipped. On the opposite side of the embankment, the bridge can be discerned amongst collapsed rubble, the sloping wall and a ramp leading towards it. Later sketches of the arch survive with the NER archive in the NRM.

Plate 4. Both sides of the buried accommodation bridge now buried beneath the embankment

The void created by the buried accommodation bridge or culvert is hazardous to users, especially horses, although being on the slope of the embankment it is not a well-used area. It is recommended that it be excavated archaeologically and if enough survives, conserved and re-exposed.
-

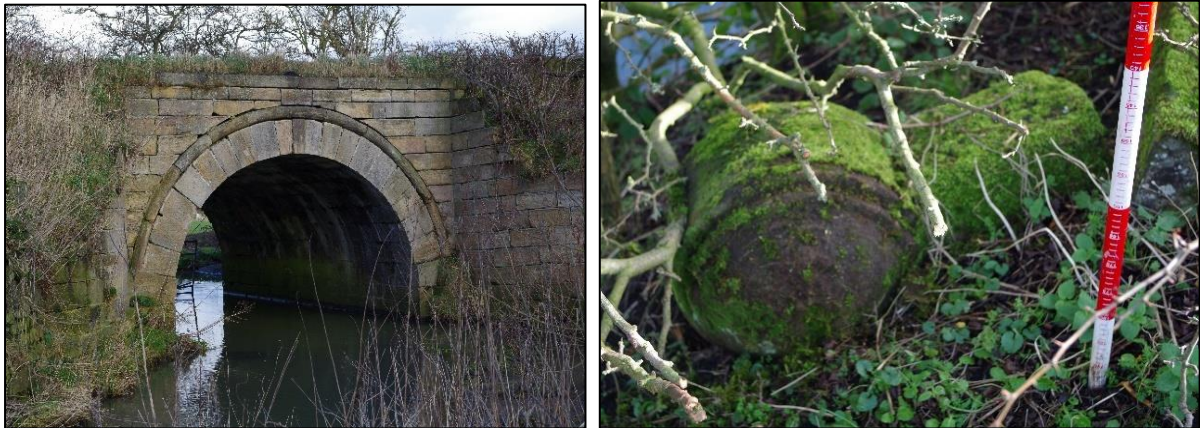
Beyond the farm there is an attractive crossing known as Hummerbeck Bridge (SDR128). This fine sandstone bridge has been decorated with an arched string course and curved wing walls with rounded topped piers. The north side of the culvert is amongst trees and is suffering from vegetation growth and the rounded cope from the terminal has fallen off and is lying amongst the vegetation. Such copes are distinctive to a number of S&DR bridges and walling and so it is especially significant. However, the culvert could be relatively easily restored to its former glory. The wing walls along the riverside are not in such good condition and are suffering from tree growth and will need attending to as any future users of the right of way will be tempted to come down the bankside in order to obtain a better view of the culvert.

Plate 5. Hummerbeck Bridge (south side) and fragments of the north side of the bridge parapet knocked over and lying amongst vegetation

Hummerbeck Bridge needs some conservation work to its top courses and replacing the pepper pot pier on the wing walls. It also needs some vegetation removal.	Hummerbeck Bridge	High
Vegetation and litter clearance of culverts and drains (ongoing management)	The watercourses near West Auckland and Broom Mill Farm	Medium
Record stone sleepers and store in depot if ex-situ or not earthfast (with a view to reusing them)	Various	High
Local police to be informed re legal status of remains at Brusselton and asked to patrol	Brusselton Bridge area	High
Implement Blackett-Ord recommendations (in part covered above)	Accommodation bridge and adjacent walls at Brusselton	High
Support the Brusselton Incline Group in the creation of an adopt a monument scheme to litter pick and cut back vegetation on the incline	Brusselton Incline	Medium (after capital works)
Conservation works to the Milk Bridge	Milk Bridge east of Brusselton	High

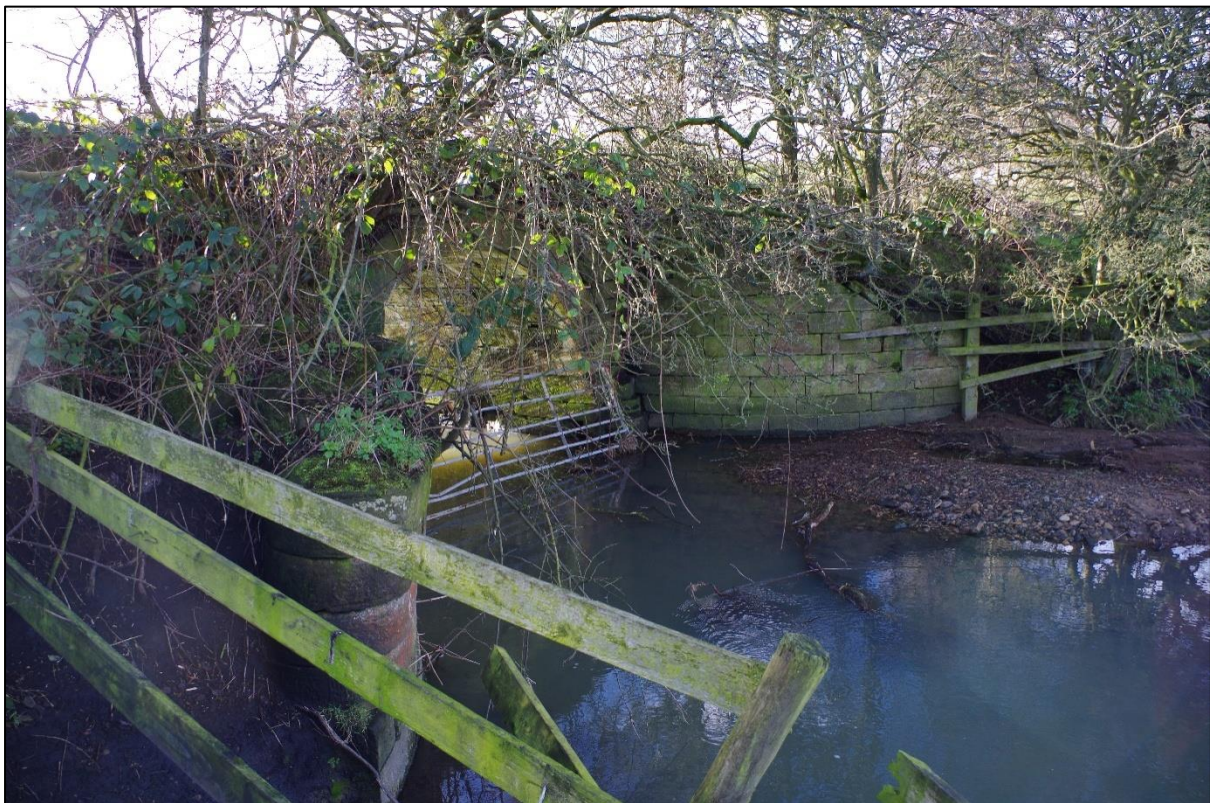
Plate 6. The north side of Hummerbeck Bridge.

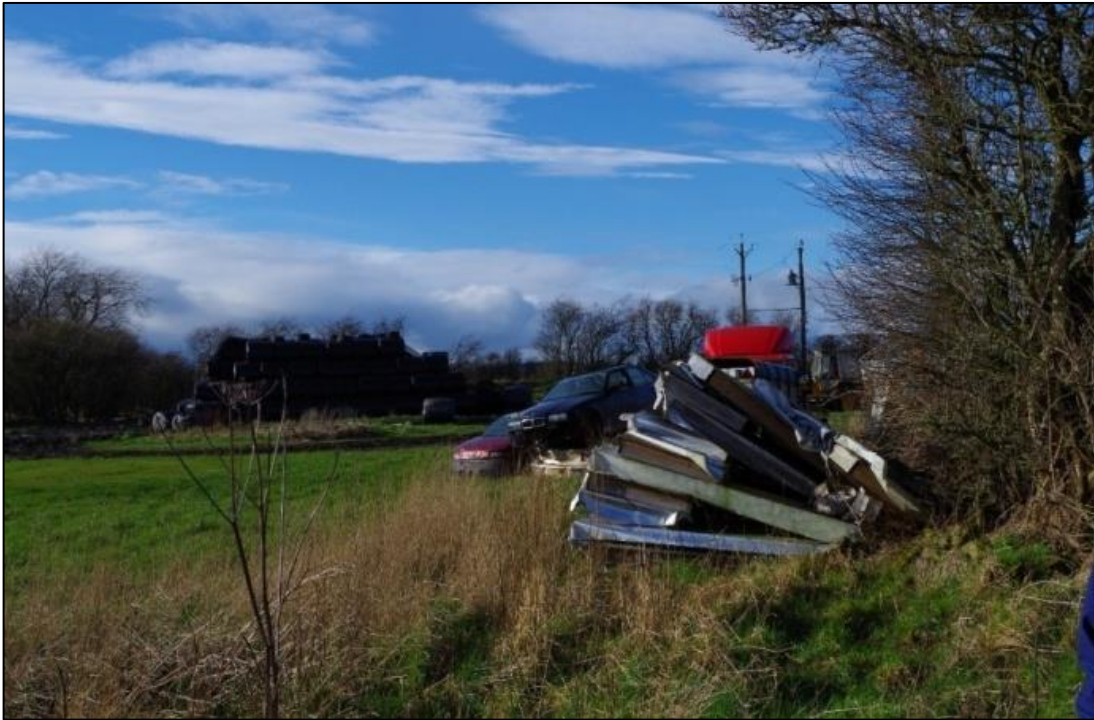
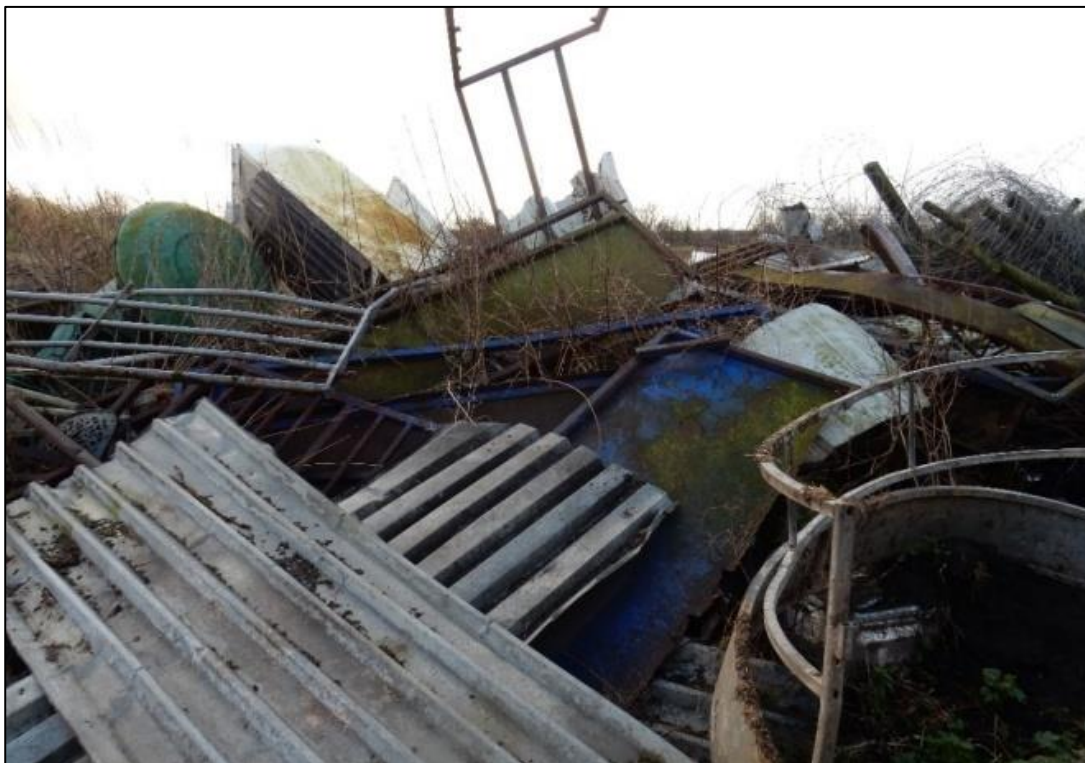
- 🚧 The path alongside Broom Mill Farm is being used to dump cars, white goods and farm machinery amongst other unwanted items. It is consequently an unattractive place to walk. It also obscures the boundary walls and is probably damaging them. This stretch of trackbed is scheduled and dumping on a scheduled monument is not permitted.
- 🚧 From the bypass, barbed wire has been mounted along the top rail of the fence on the side of the bridleway at Broom Mill Farm and should be moved to the other side.

*Plate 7. (Top). Dumped cars and trucks at Broom Mill Farm (off the scheduled monument).
Plate 8. (Below). Old farm equipment along the path at Broom Mill Farm (on the scheduled monument)*

Crossing the Bishop Auckland bypass is hazardous and surprisingly difficult.	Crossing at Bypass	High
Clear fly tipping at Broom Mill Farm, and over spill of scrapyards at Shildon	Broom Mill and approach to Shildon's Hackworth Industrial Estate	High
Vegetation removal along path at Shildon to keep path clear	Path between Milk Bridge and Shildon and on approach to Locomotion	High
The bridgeway becomes a footpath at Broom Mill Farm (although its nature does not alter) and so there is currently no legal access for other users. The route might need to be upgraded to a bridgeway.	Broom Mill Farm area	Low
The path is also badly flooded and rutted in winter at Broom Mill Farm and is difficult to use.	Broom Mill Farm area	High
The line immediately east of Burnshouse Lane at Bankfoot Farm is private property and as it is being used as garden it is unlikely to be available for a rail trail. An alternative route will need to be found – this can use the quite & attractive Burnshouse Lane that joins the Roman Road Hags Lane.	The line immediately east of Burnshouse Lane at Bankfoot Farm up to Hags Lane	Medium

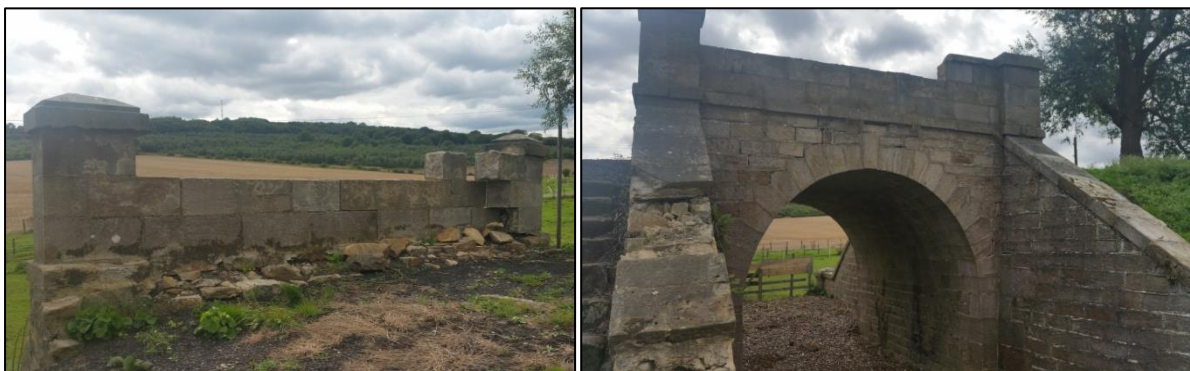
The Brusselton accommodation bridge is one of the best surviving accommodation bridges on the S&DR route. It was built to allow the farmer of 1825 access to his land between both sides of the line. It was, and still is, an attractive structure with its sloping wing walls terminated in coped piers; with a string course and prominent pilasters to the parapet corners. The steps down to the road are made of upcycled stone sleepers. The bridge has been vandalised, but conservation work is in hand to repair the damage.

Plate 9. Brusselton Accommodation Bridge, showing recent vandalism and stone theft to parapet and water tabling.

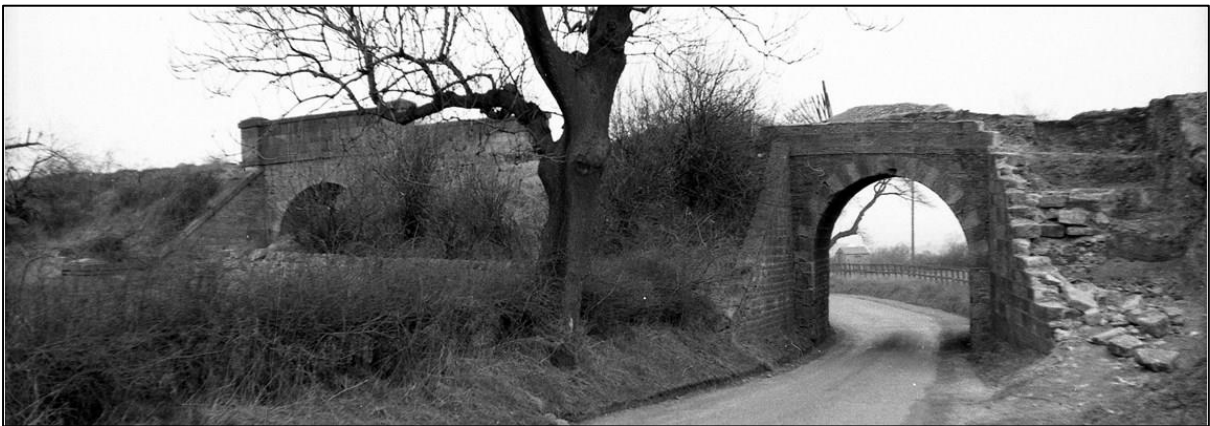
The trackbed crossed the road by bridge over Brusselton Lane, however this was demolished around 1954. The road was also widened on the east side at the same time. Scarring on the west sides marks where the bridge abutment was located.

Plate 10. The road bridge during its demolition in 1954 looking north, with the accommodation arch to the left (above). The same view in 2016 (below)

There was a road bridge that the S&DR incline used to cross Brusselton Lane. It was demolished in the 1950s. Sufficient detailed information exists to justifiably rebuild the bridge and reinstate the crossing, however its use would be limited to footpath users because of the presence of stone sleepers on either side. Any replacement bridge would be wider to accommodate the widened road.

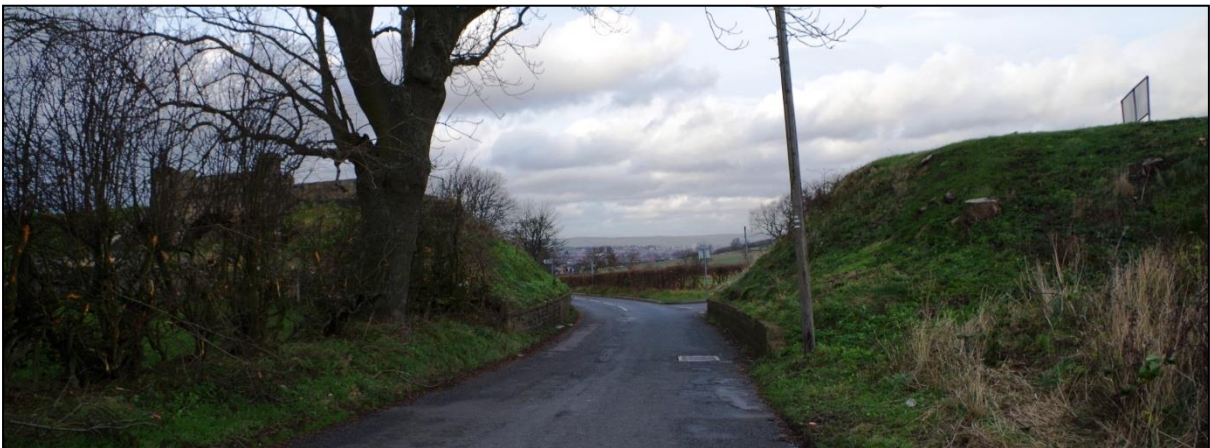
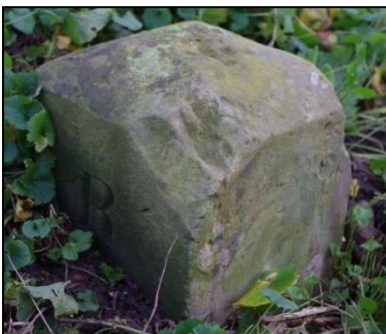
Further up the lane from the site of the road bridge, there is a small square stone with the initials S and R carved on to it at the foot of the incline bank. This is a parish boundary stone, and the letters refer to the parishes of Shildon and Redworth. It is likely that the S&DR Company would have had to ensure that such administrative boundaries continued to be marked, after the line was built.

Plate 11. The parish boundary stone located at the south-east corner of the demolished road bridge.

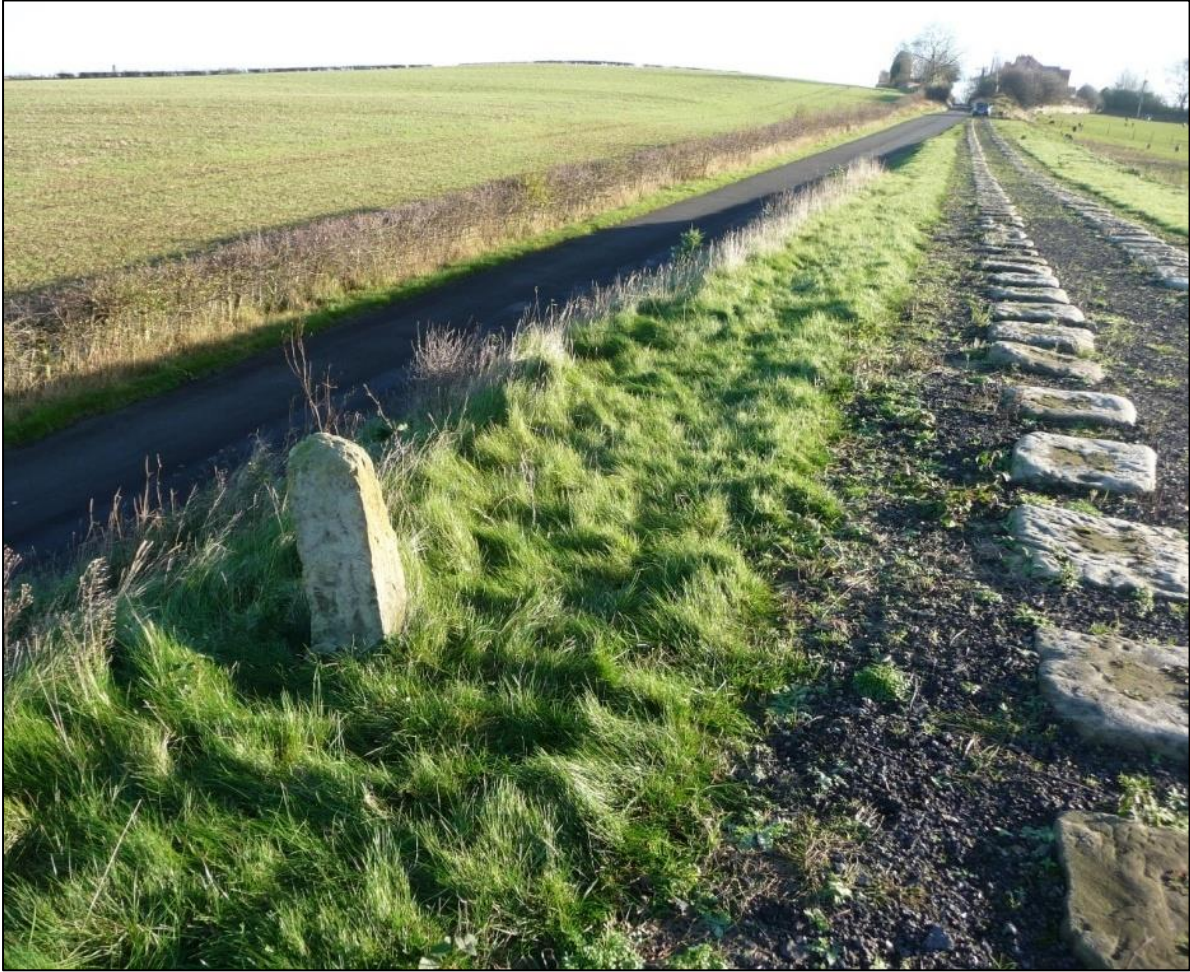
Work by the Brusselton Incline Group exposed the sleepers on the trackbed surface and cleared vegetation away from the surface. This line is now in excellent condition, although a boundary stone is laminated and remains vulnerable. It probably once had the text, Stockton 20 ¾ miles.

Plate 12. The Brusselton Incline looking east with extant sleepers and an S&DR milestone

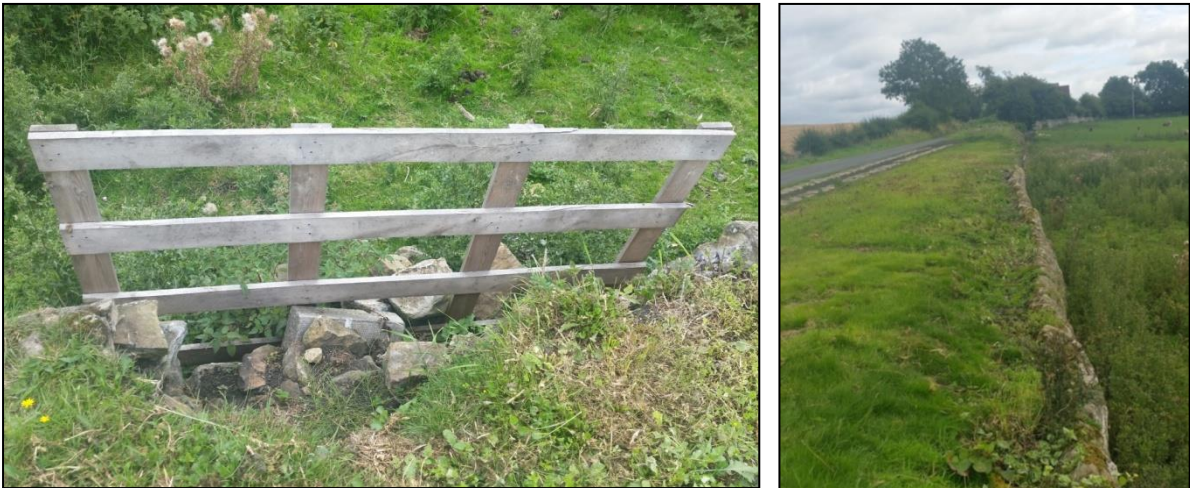
The trackbed is in excellent condition nearly as far as Brusselton village. The boundary walls on the north side were restored by Sedgfield Council in the 1990s, but those on the south side still require conservation. These walls also act as retaining structures to the incline embankment. The walls here and at West Thickey Farm all survive to virtually full height.

Plate 13. The boundary walls of the Brusselton Incline embankment also act as retaining structures. The north side was repaired in the early 1990's but the south side and localised areas are also in need of repair all the way to the top and the reservoir.

The boundary walls at West Thickley Farm and along both sides of the incline up to Brusselton village merit conservation as they survive to full height. They also act as retaining structures for the embankment. While the north side was restored in the 1990s, the south side is showing signs of failure. Repairs identified in the BOCE¹ report should be actioned. The remaining length of walling requiring restoration is about 0.69km.
-

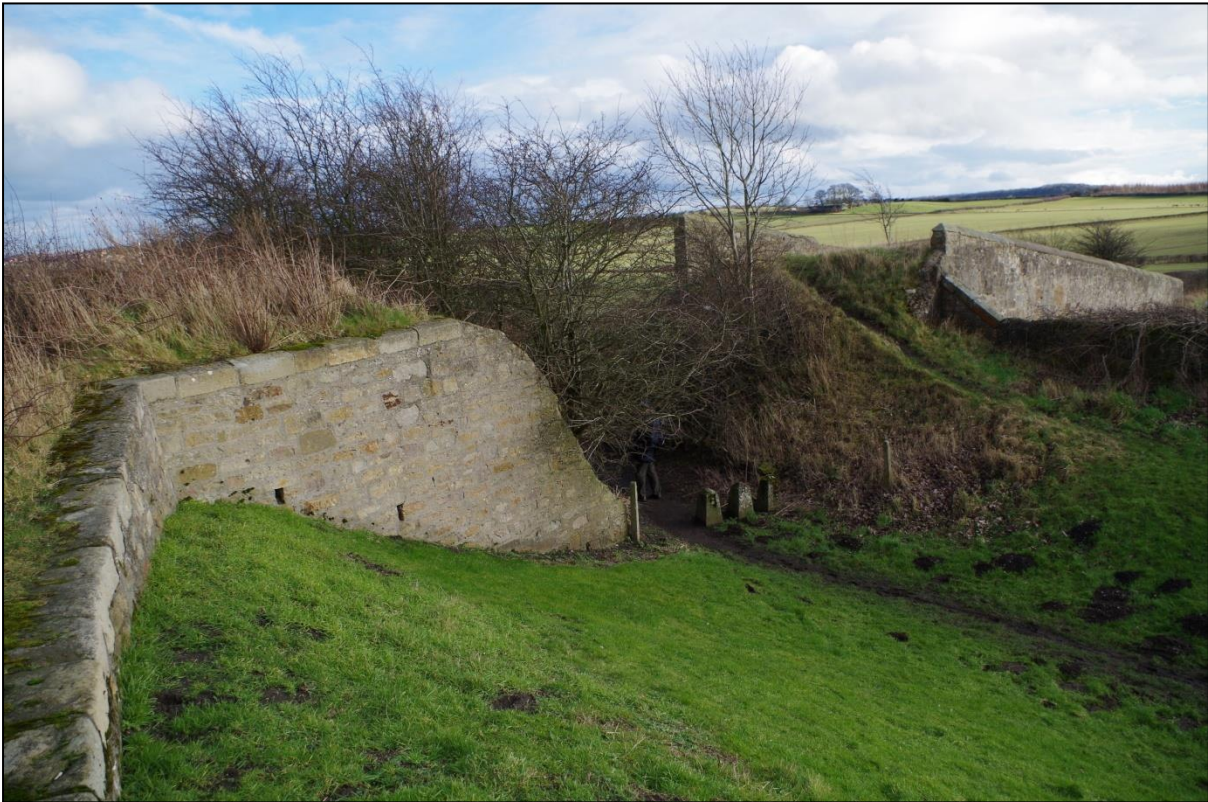
Further east, there is an accommodation bridge known locally as the Milk Bridge (SDR117). This was designed to allow the farmer to take his or her cattle across the incline. Its decking was removed in 1958/9 but the abutments survive on the west side, but one is missing on the east side. A long ramp approached the bridge from the lower fields on the south side. The wing walls include reused sleeper blocks and so have been repaired since its construction. The 1825 route east of Brusselton Village is a footpath continuing between boundary walls through a modern concrete underpass beneath the A6072 as far as Shildon and the start of the Industrial Estates.

Plate 18. The imposing remains of the Milk Bridge on the eastern side of Brusselton Incline. An original structure currently with no legal protection other than being in a conservation area.

Boundary wall repair is required east of the Milk Bridge towards Shildon, a length of walling totalling 0.7km although restoration of walling can be selective within this amount as some is in very poor condition and resources should be concentrated where existing walls can be saved.

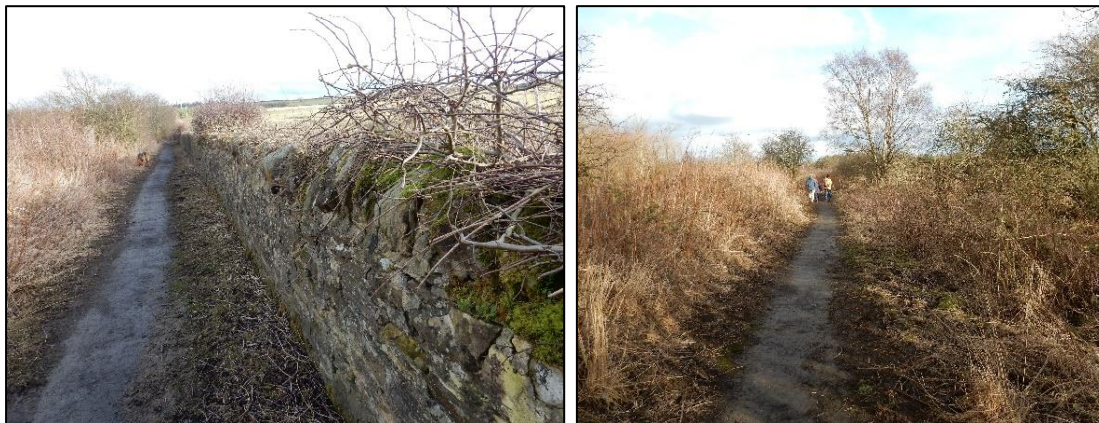
Plate 19. Left: Good quality S&DR boundary walls in places, but the footpath would require widening if more users are to be able to cycle along or use mobility vehicles. Right: Ongoing vegetation clearance will be required to keep the path open

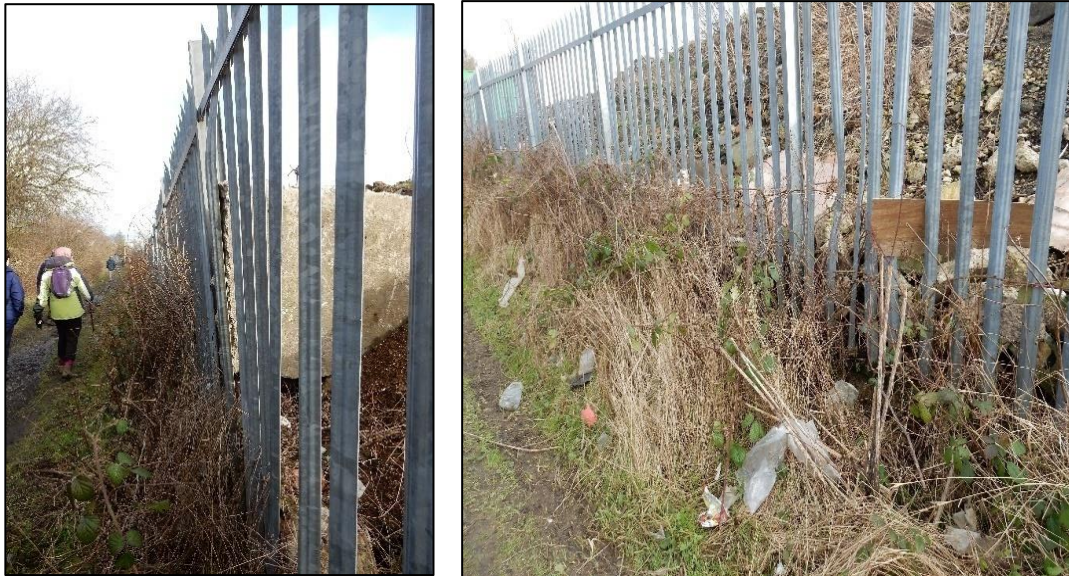
The scrap yard/recycling centre immediately adjacent to the south side of the track and path, has scrap spilling on to the path and the metal boundary fencing is bucking under the weight of the scrap. The footpath here has plastic exposed where it has worn through.

Plate 20. Scrap yard, unattractive boundary, spillage and litter

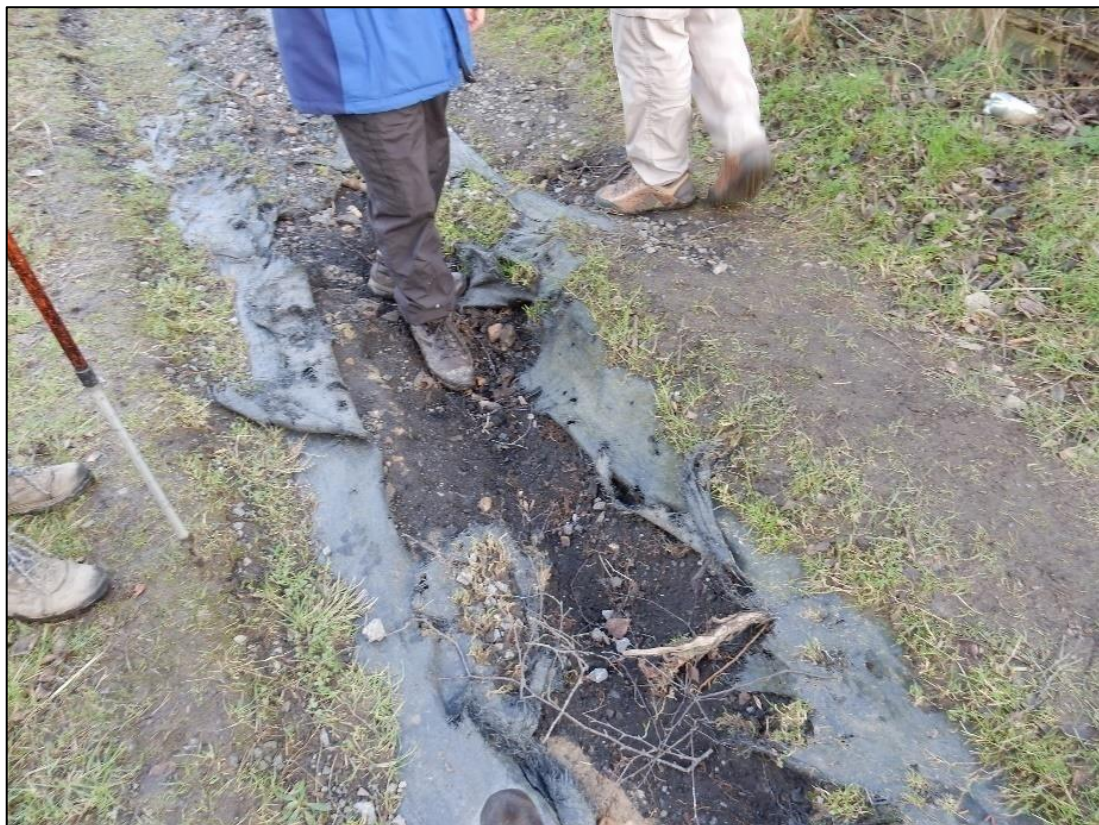
Plate 21. The footpath is worn and needs resurfacing
