Parkgate Conservation Area Character Appraisal

For Darlington Borough Council

April 2015

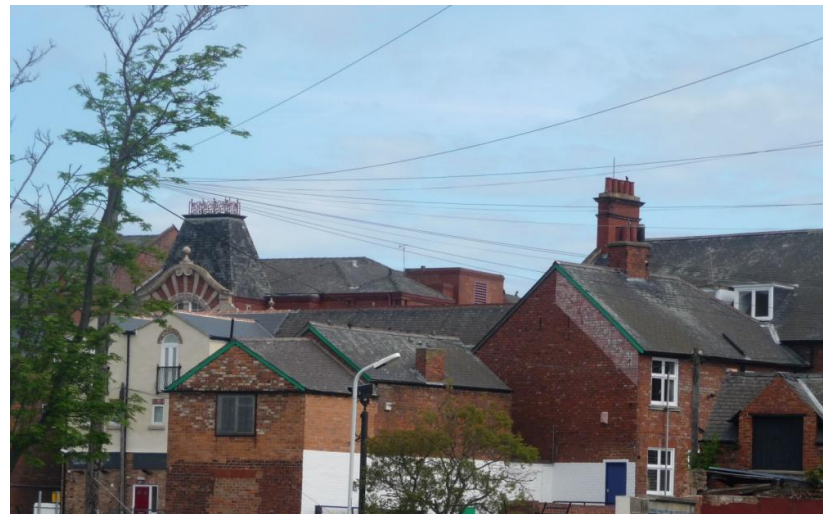
Plate 1. Parkgate from the back streets where the roofscapes can usually be best appreciated

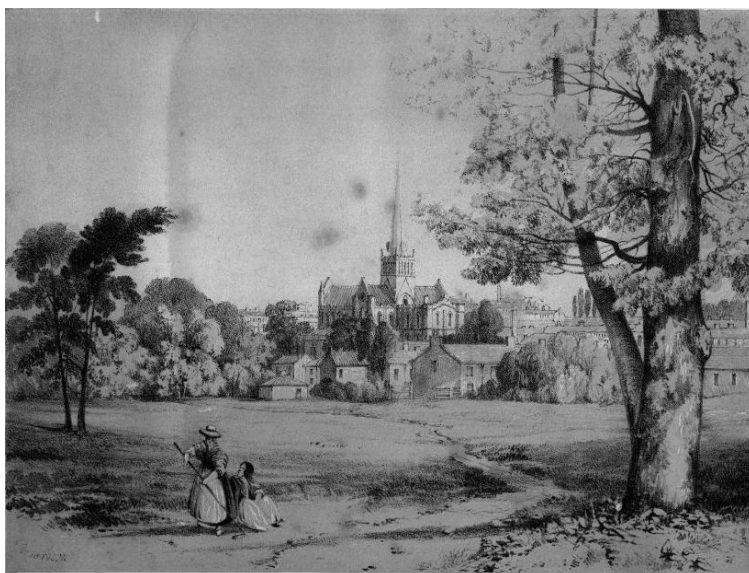
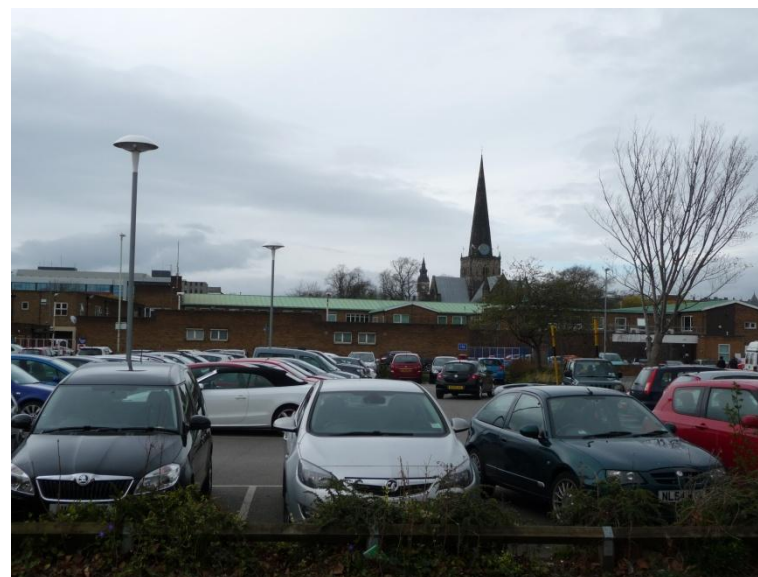
Plate 3. View across the Park towards St. Cuthbert's. Left: The backs of the houses representing the early expansion of Parkgate (1822-40 George Richardson). Right: the demolition in the 1960s and subsequent redevelopment has destroyed much historic character and so this area is immediately outside the proposed conservation area. However future developments here should enhance the conservation area.

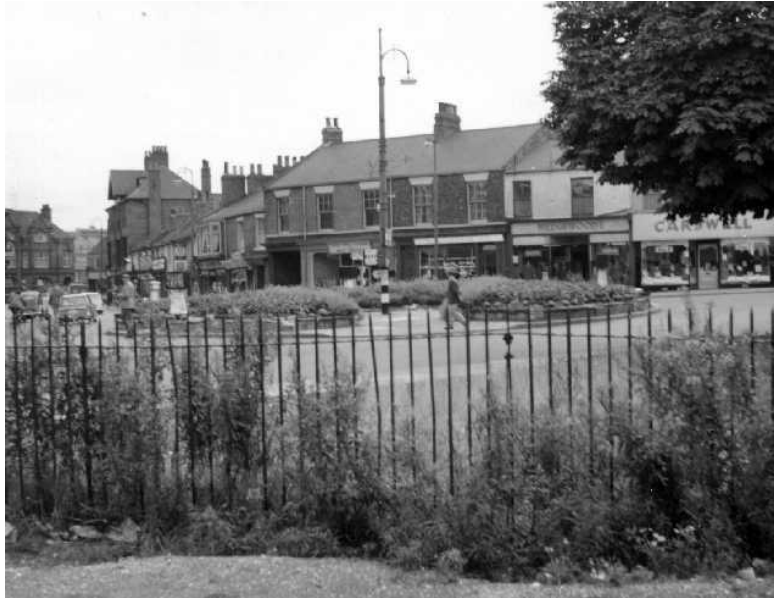
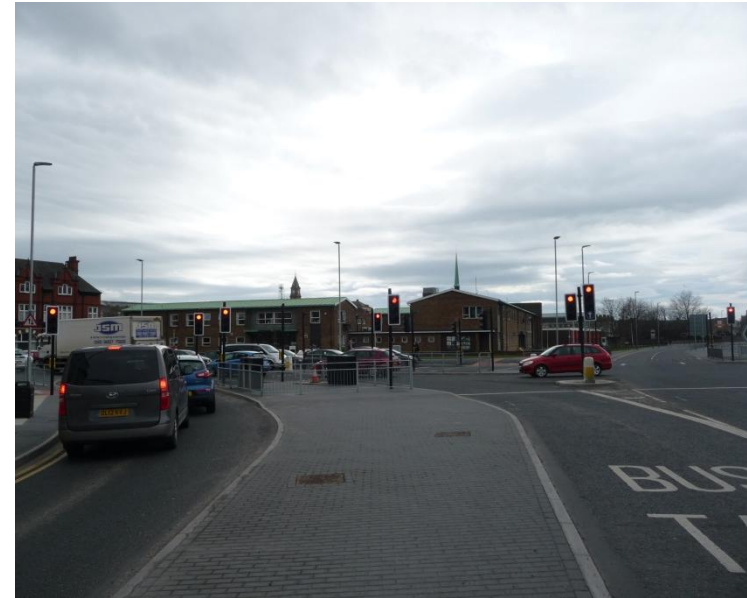
Plate 4. The construction of the ring road removed much of historic and architectural interest from the town and altered the density of building stock and the historic street pattern. The ring road has also served to divorce Parkgate from the town centre. Date of photographs 1961 (left) and 2015 (right).

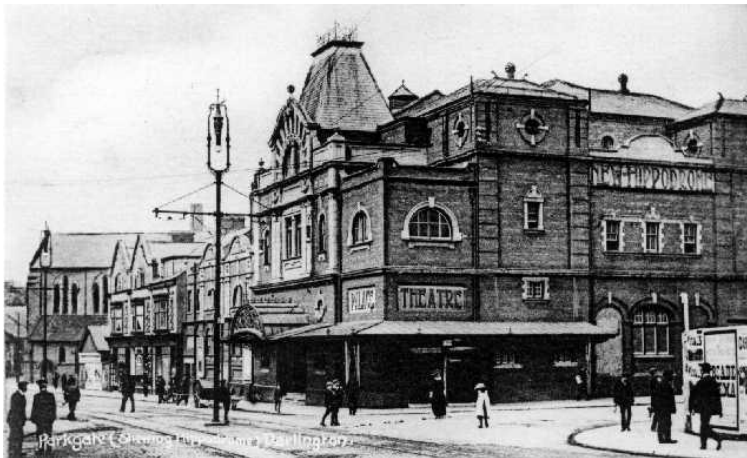
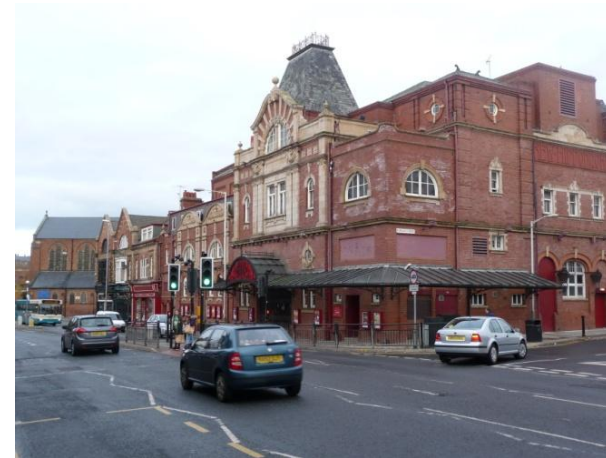
Plate 5. This group of buildings around the Civic Theatre is remarkably intact and not much altered since 1921 when the first photograph was taken

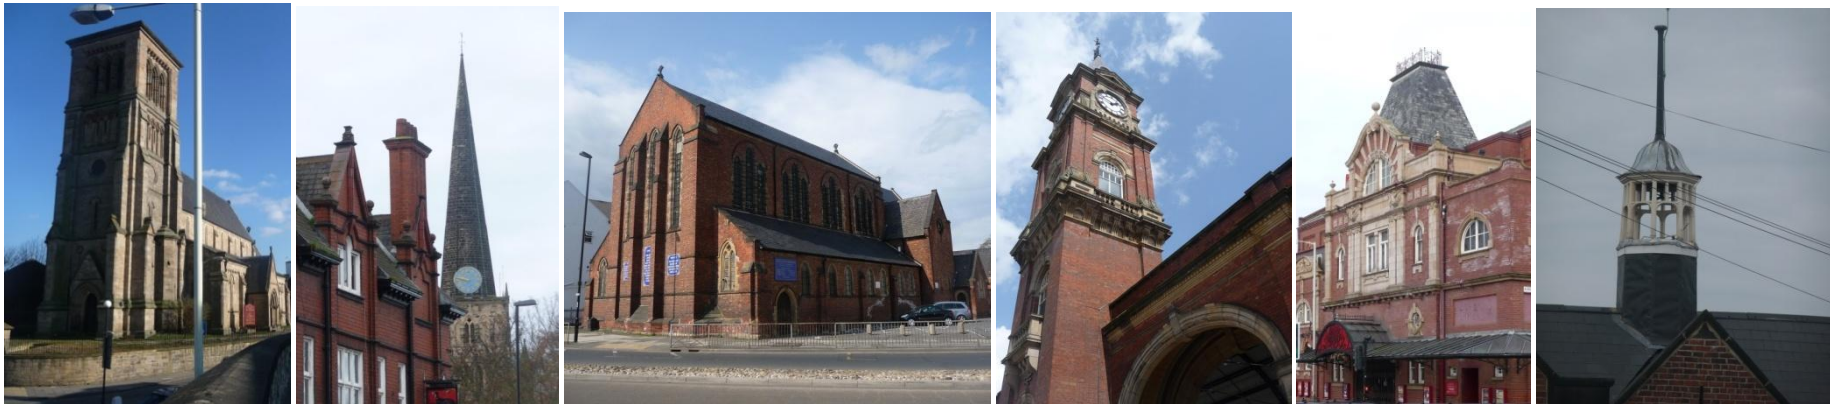
Plate 6. Landmark buildings in or near the conservation area which provide prominent architectural features and roofscapes worthy of conservation. (Left to right: St John's; St. Cuthbert's (outside the conservation area); St Hilda's, Bank Top Station (outside the conservation area) and the Civic Theatre

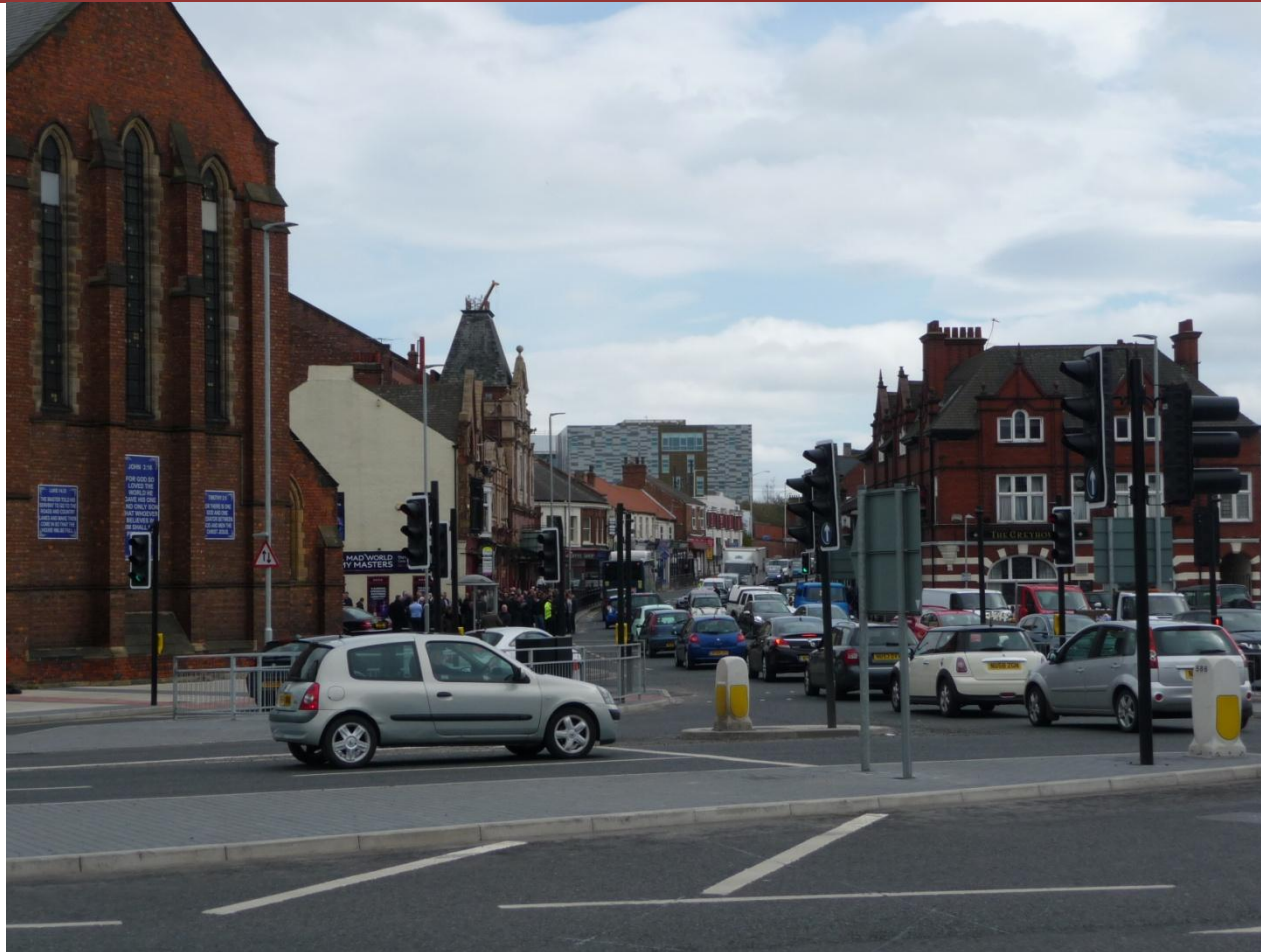
Plate 8. Negative features in the conservation area include the dwarfing of the view from the town centre by the new Business Centre building on elevated ground and the divorcing of Parkgate from the town centre by the ring road and its proliferation of traffic lights and highway signs.

Sadly, the recent construction of the Business Central Building has now created a new terminus to the key view from the town centre to the west. This has adversely affected the appreciation of views of the rooftops including that of the Civic Theatre and its disproportionate scale on elevated ground dwarfs the entire conservation area when viewed from the town centre.

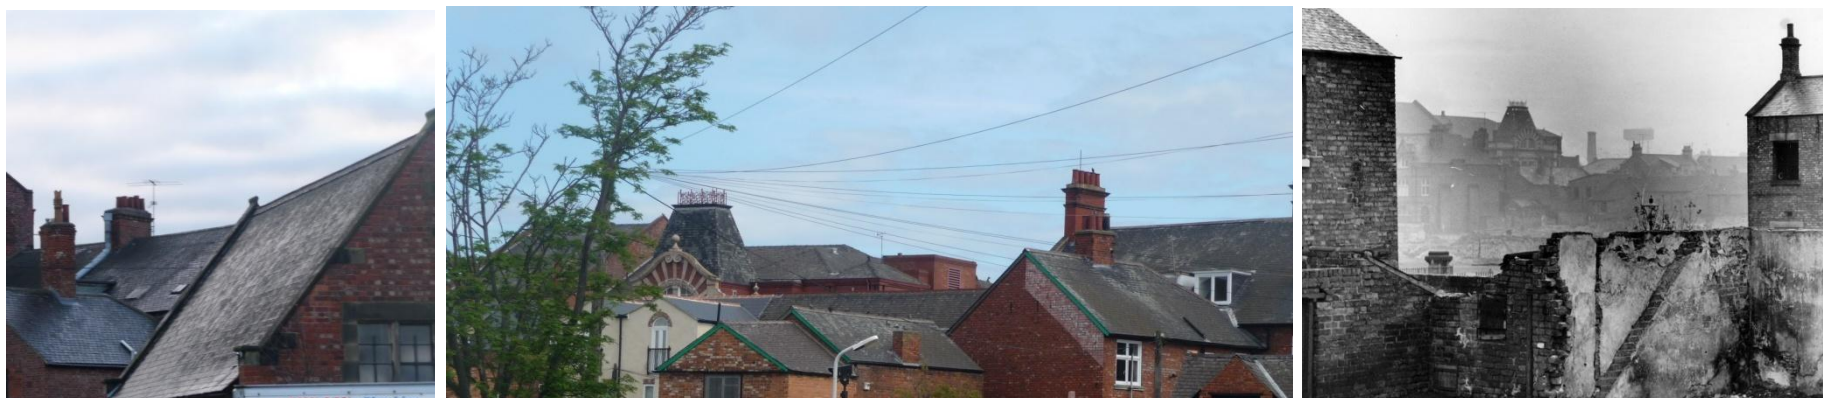
Plate 9. Jumbles of rooflines can currently be appreciated from the vacant development plot on Brunswick Street (left) and from the car park on Park Lane (centre), but the roofscape was interesting even in 1959 when viewed from Luck’s Terrace which was derelict and due to be demolished for the Town Hall. The distinctive lacy pyramidal top of the Civic Theatre can be seen in the distance (right picture courtesy of The Northern Echo).

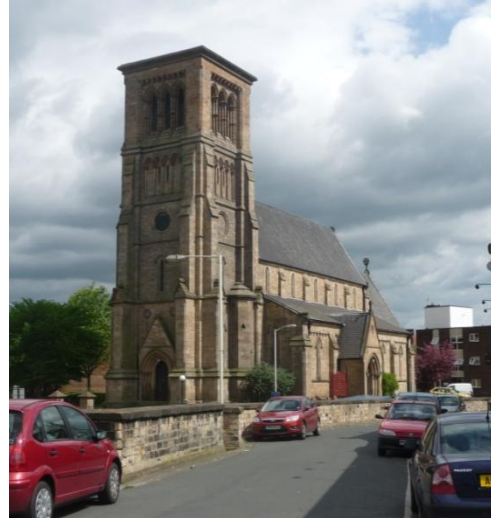
Plate 10. St. John's Church (also known as the Railwayman's Church) by John Middleton as published in 1854 showing the spire that was intended and, left, in 2013 – the spire was never built. The same view is no longer possible due to increased urbanisation.

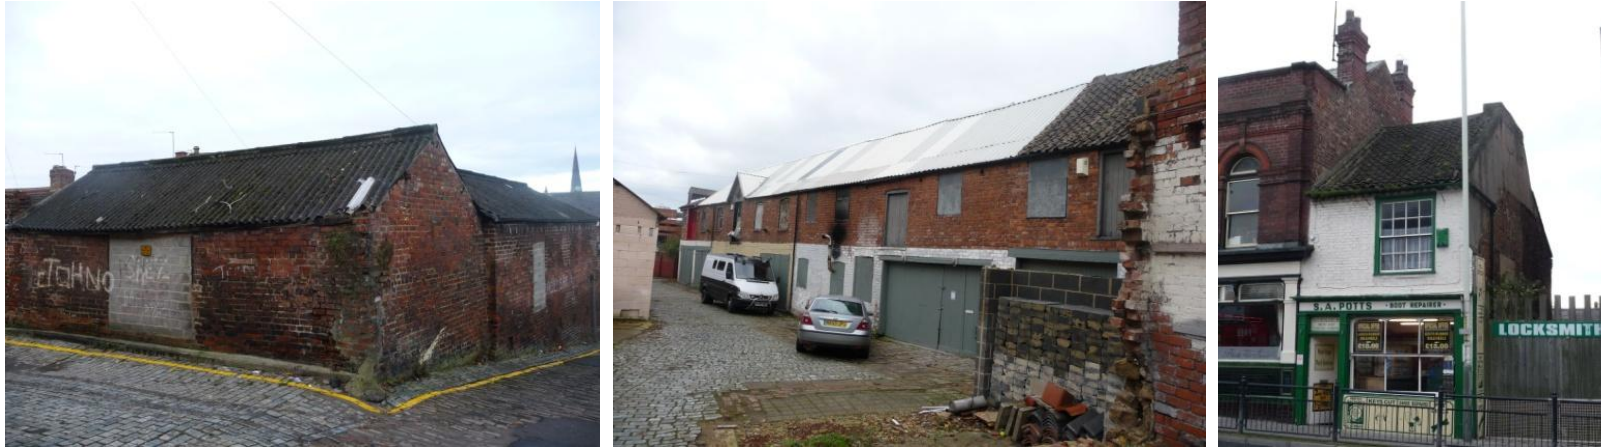
Another little building on Parkgate, now a cobblers, must have once been infill, but its neighbours have clearly been replaced and so the later infill that was, has become the earliest building in the row, reflecting a cottagery character more reminiscent of late 18th, early 19th century Darlington than the Edwardian architecture of its surroundings. No sandstone is used on these most basic of buildings and all have lost their traditional roofing materials except the last roof on the tannery with its ramshackle wooden louvres and pantile roof.

Plate 11. The buildings that Parkgate forgot.....early architectural survivals in an Edwardian character area

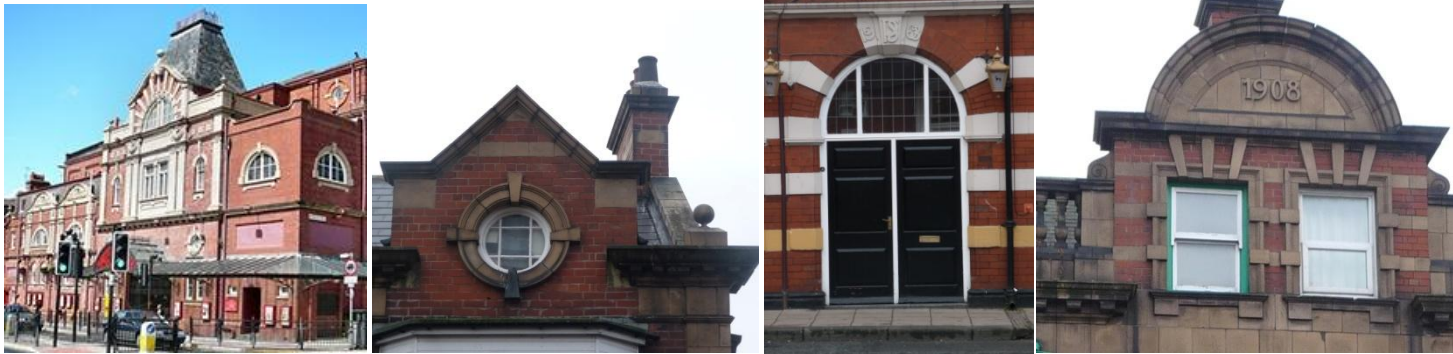
Plate 12. The details from the Civic Theatre are to be found in other properties on Parkgate. Most buildings are of brick with sandstone detailing, but many also make use of glazed brickwork, interesting gable features, circular and semi circular windows , starburst and starburst derivatives and art nouveau date stones.

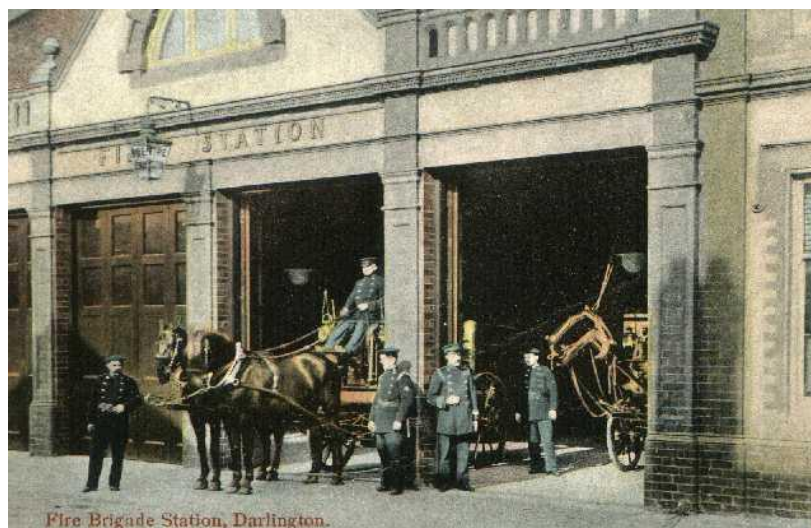
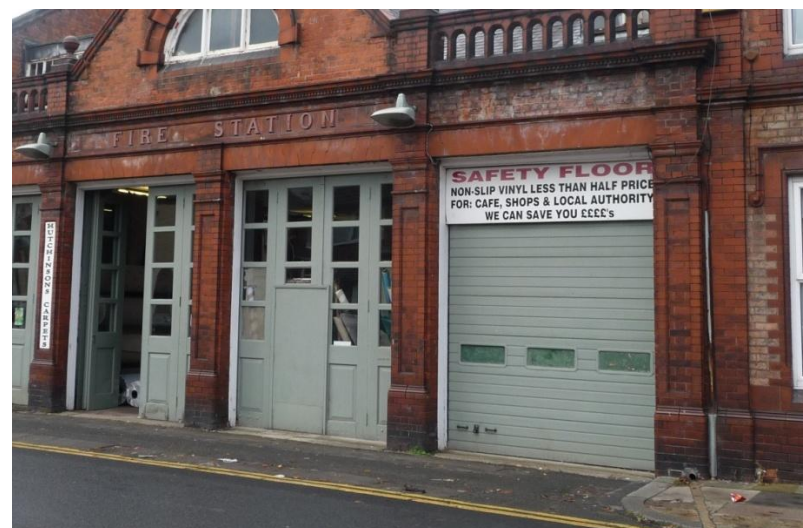
Plate 13. The fire station on Borough Road has survived remarkably well with only the loss of its central lantern and the replacement of traditional windows with plastic ones in the house next door since 1905 when the first photograph was taken (left). The colour tint added to the post card misleadingly suggests that the building was of green glazed tiles and stone rather than brick.

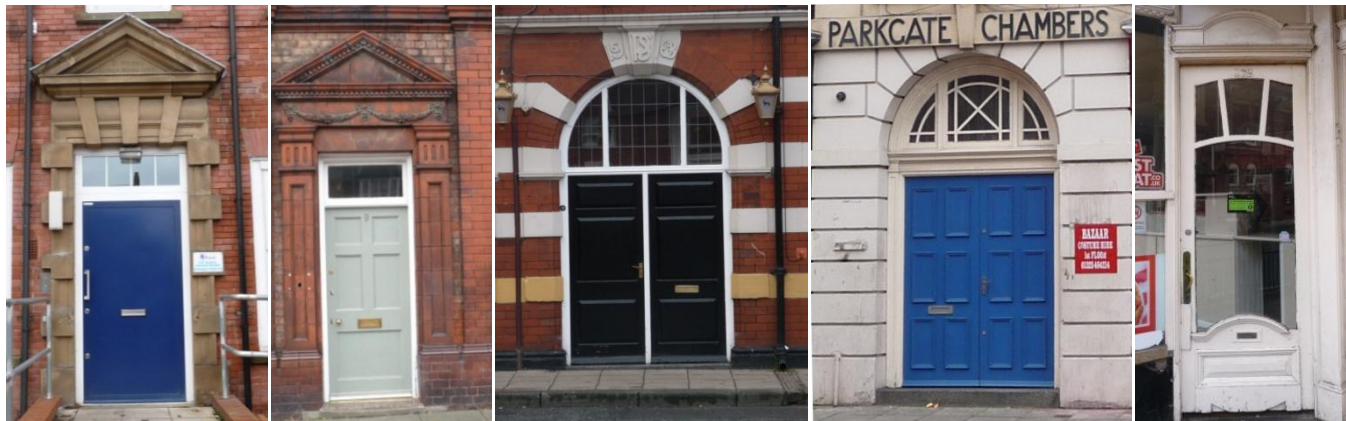
Plate 14. Door styles mark the transition from classical pediments to the simple clean lines and glazing details of art nouveau and the 1930s

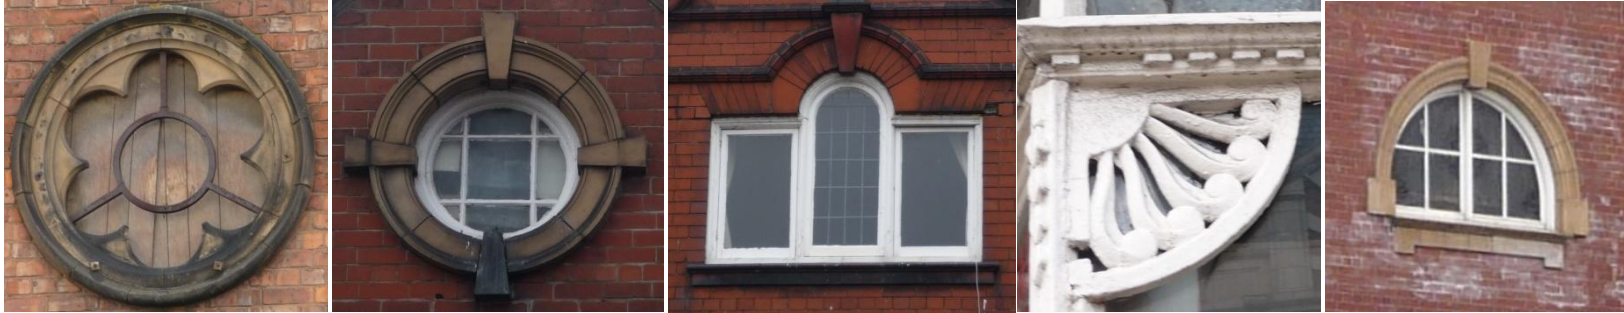
Plate 15. Few traditional windows have survived in this area, but those that do are predominantly 1904-8. Windows are in a variety of shapes, although the circular and lunette are especially popular amongst the red brick Edwardian buildings. Shop front windows have retained their small scale and where they survive, are mostly 1920s-30s; most are in urgent need of conservation.

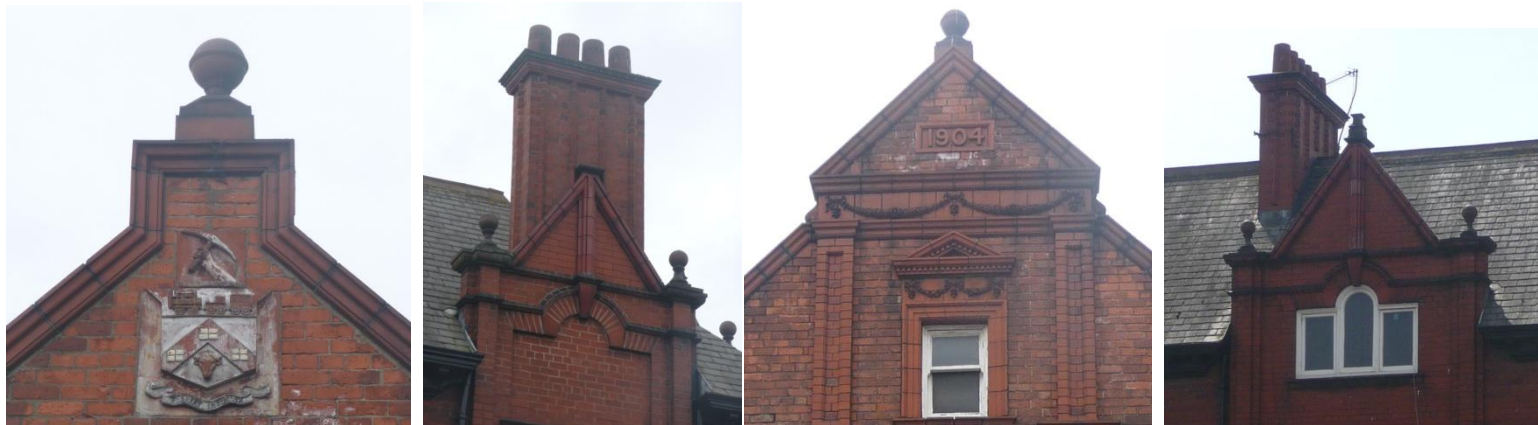
Plate 16. Distinctive gable features in Parkgate using (glazed) red brick and including tall chimneys, using window detailing, string courses, ball finials, swags, crests and pilasters to add interest

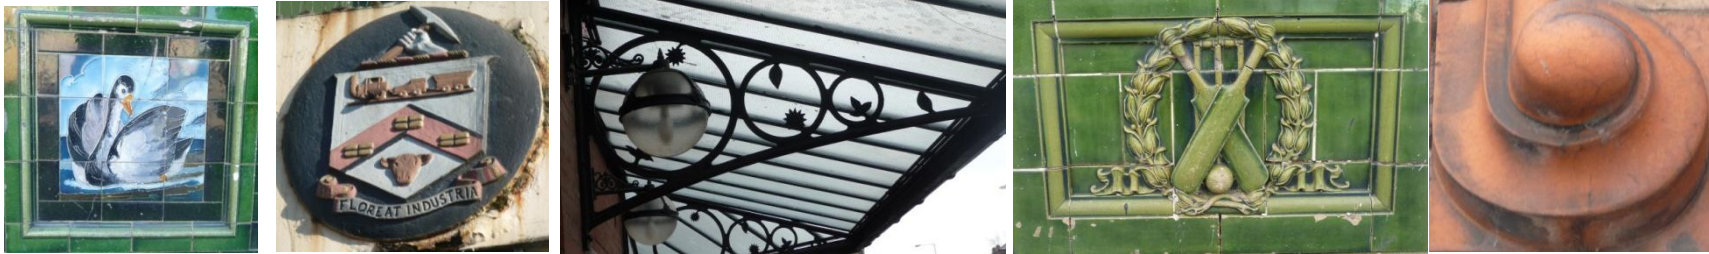
Plate 17. It is the small decorative details that combine to make Parkgate of architectural and artistic interest. The palette is rich in glazed terracotta and green glazed tiles

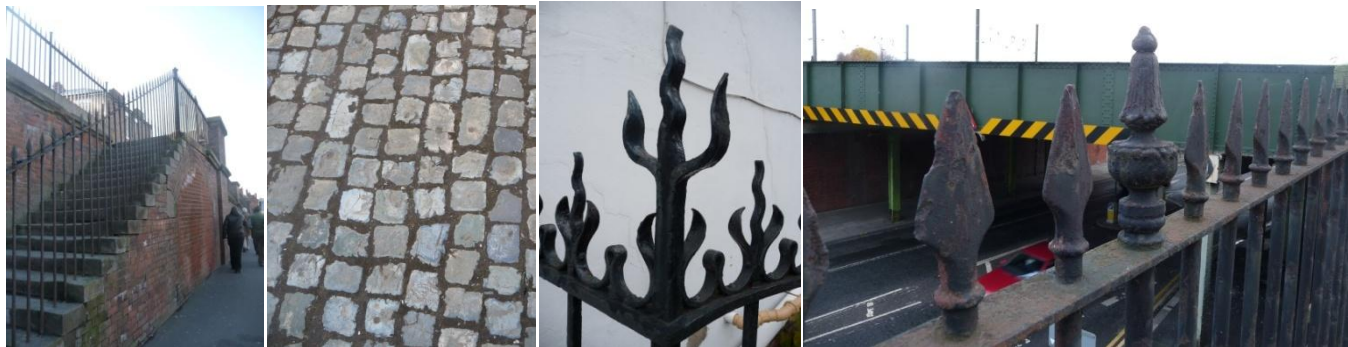
Plate 18. Although private domestic houses have lost their original railings (apart from nearby Hargreave Terrace), Parkgate has a number of original railings on public buildings, although some of those at St John's have been replaced. The difference in ground levels between Parkgate and Bank Top has necessitated two flights of stairs complete with railings that add interest to the street scene. The railway bridge is a reminder of Darlington's railway heritage and is visually linked to St. John's, known as the Railwayman's Church and the arches of Bank Top Station. Scoria blocks are now largely limited to the back lanes, but merit retention for their historic interest, as an example of Victorian recycling and for their marble-like qualities when exposed to rain.

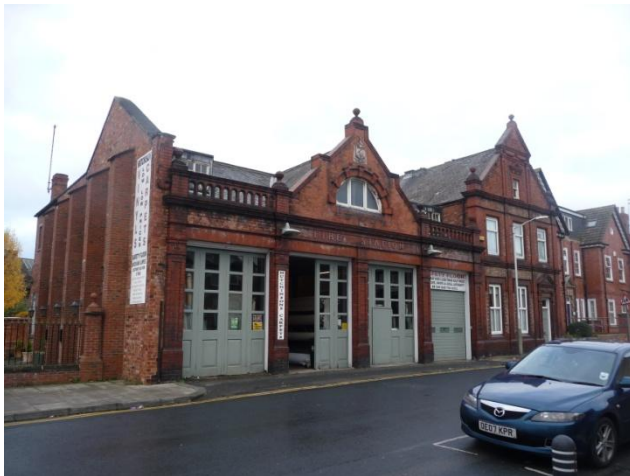
The Former Fire Station and house adjacent. Borough Road. This building has retained its architectural features and use of space despite going through alternative uses as an ambulance station and carpet shop. Its architectural details are typical of the area in its choice of matching ornate gables with ball finials, its use of a demi-lunette window and balustrading to the roof. Its materials of glazed red brick in contrasting colours are also typical and the house benefits from the addition of small decorative details such as pilasters, swags, a pedimented doorway and window labelling terminated with terracotta swirls. The town crest is located above the doorway gable and can also be found on other civic buildings such as the railway bridge. The early 20th century was the Golden Age of fire station design in London (English Heritage 2011, 11) and this ornate example (along with other similarly designed buildings) would suggest a similar Golden Age in Darlington. It also coincides with the introduction of motorised fire engines nationally, although historic images show that horses were still in use at this site when the building was new. The house and fire station may merit listing grade II because of their group value with the Civic Theatre both reflecting grand Edwardian designs and because it represents a relative unaltered fire station and associated house from a transitional period in fire fighting from horse to motorised engine.

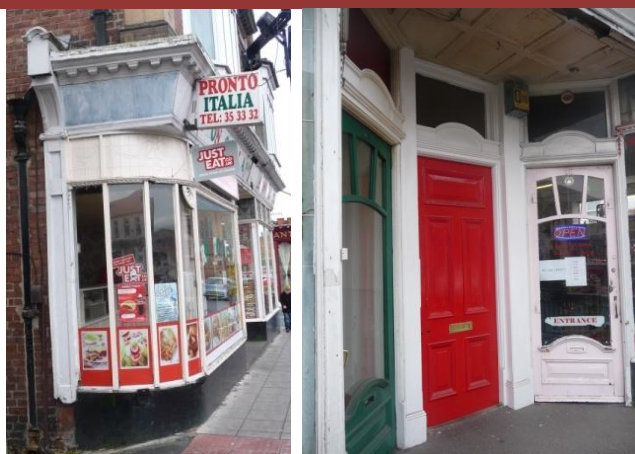
Early 20th century shop fronts on Parkgate. These are important as they have retained their decorative detailing to the windows with iron spandrels, although some of the stained glass windows have been painted over. The gently curving glass is attractive and the simple shop window consoles and pilasters are typical of this row of shops in Parkgate. The narrow 1920/30s shop doors with a sunburst derived glazing pattern is also of note

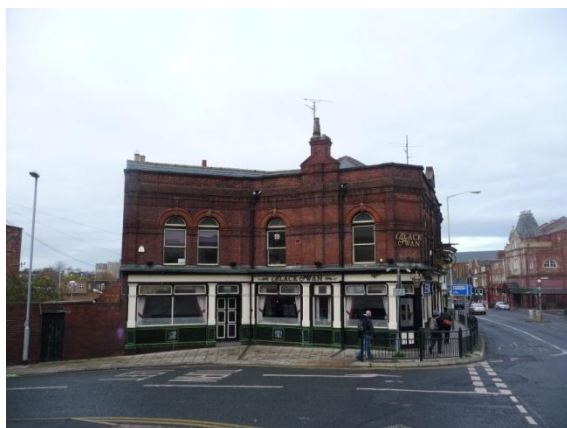
The Black Swan Inn on Parkgate combines the two main materials and colour palettes of the character area; namely red brick and green glazed tiles. The rounded arched windows are also distinctive and are repeated on other nearby buildings. The shapely chimneys reference the shapely gables of adjacent properties and the colourful scenes of the black swan around its base have been a source of delight for nearly a hundred years. The delicately etched glass and decorative pilasters divide the building at ground floor level. Its street corner position means that it makes a particularly strong contribution to the streetscape.

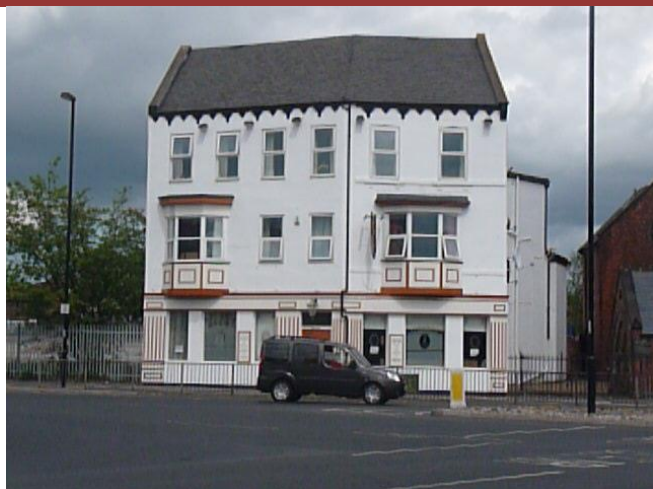
The Cricketers, Parkgate is the only building remaining on what was Clay Row and presumably takes its name after the cricket ground which was located in the Park in the mid 19th century 225m south. It has been extended in modern times and recent interventions have done much to harm its historic character; the replacement of its traditional windows with sham sashes is perhaps the most harmful intervention of all. However it is in a prominent position and does retain some traditional architectural features including the decorative green glazed cameo of cricket bat and ball, broadly classical proportions, decorative pilasters to ground floor level, string coursing to break up the facade and below eaves detailing. Its side gables cry out for neighbours – this should be set within a row of high density buildings. Photographs from the 1960s suggest that it was not originally rendered either.

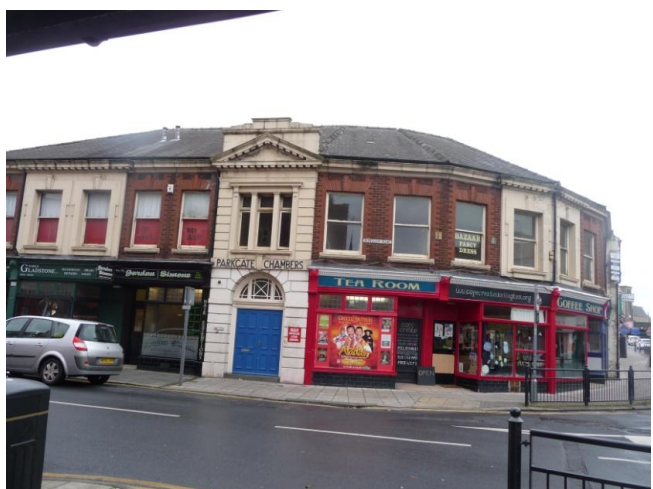
Parkgate Chambers, Borough Road occupies a prominent position on the corner of Parkgate and Borough Road. The mixed materials at first floor level and the variety of colours at ground floor level, break up the facade with a loss of harmony. However the central pedimented doorway on the corner and the round headed overlight has some street presence and so the condition of this buildings has the potential to impact on the overall character of the area. When it becomes run down, so too does the appearance of Parkgate. The shop fronts are still small in scale and retain early 20th century consoles and pilasters, original glazing bars and fascias and glazed tile plinths, but some are in poor condition.

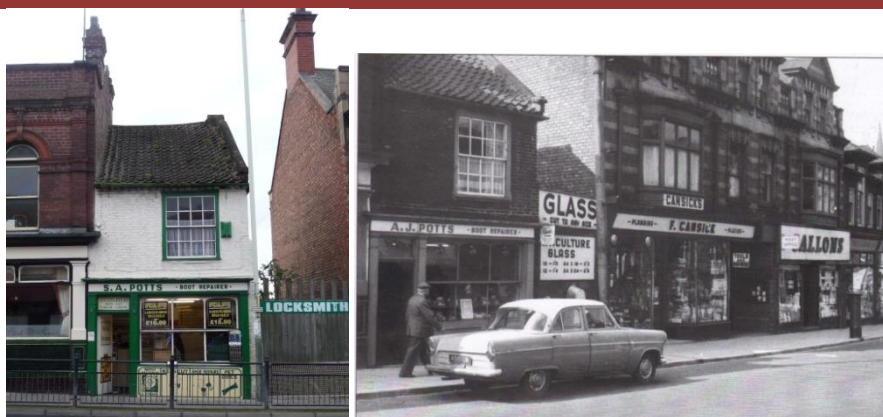
Potts the Cobblers on Parkgate represents an early building phase. It is only one bay wide and appears originally to have been infill, but its earlier neighbours were replaced in the early 20th century, leaving this 19th century brick building behind. Its single first floor window is an 8/8 pane sliding sash which must predate 1860 at least, although the shop front is probably 1920-30s, but still intact. Such multi pane sashes are a relative rarity in Darlington now, as are historically intact shop fronts; indeed this shop has stayed in the same family since at least 1966 (see historic photo). It has pretty below eaves detailing, cast iron rainwater goods and scarring on its side elevation where its neighbours once stood.

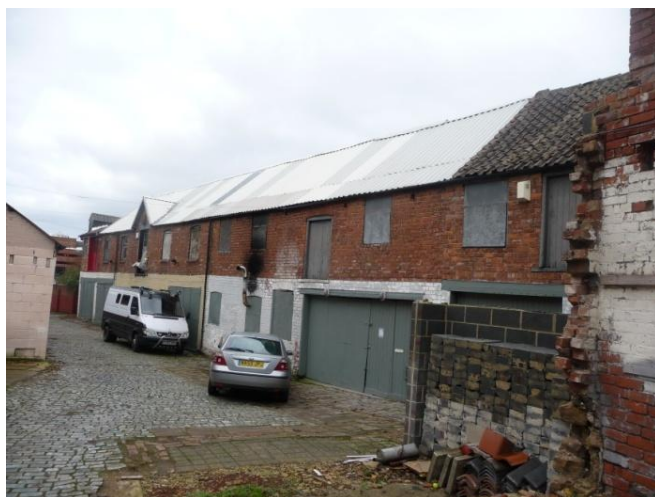
The Tannery buildings off Borough Road. This linear group of buildings are laid out along the continuation of a street pattern that predates most of the buildings in Parkgate. They sit on the area that was developed first for tanning so that the foul smelling, toxic activities could be carried out away from the town, although this particular plot was a later development dating to the mid to late 19th century. The significance of the remaining buildings is not yet clearly understood, but it is clear that they had a variety of uses reflected in their varying designs, and retain early paving in the form of scoria blocks from the 19th century and sandstone paving. The wider area was extensively developed for tanning and the remains of tanning pits may survive below ground.

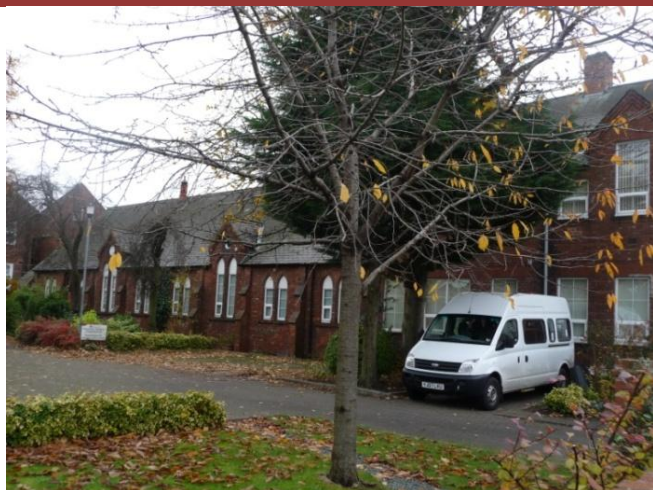
A quiet courtyard behind St Hilda's Clergy House on Borough Road consists of a low range of red brick buildings with neo Gothic and round windows which reflect the architecture of St. Helen's Church. The steeply pitched roof lines retain Welsh slate, but the windows have not fared so well. These buildings add group value to St Hilda's Club (1906) and St. Hilda's Church and also offer a back view towards the former fire station.

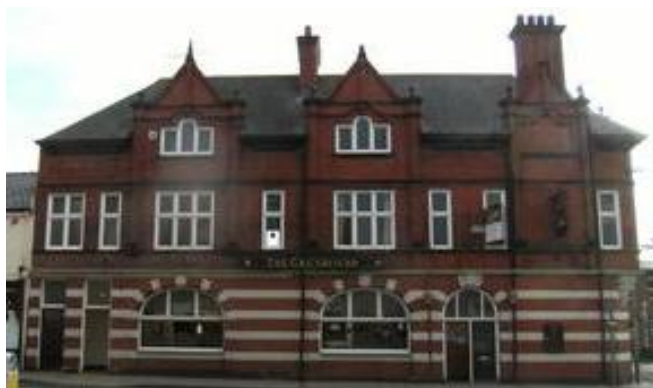
The Greyhound Inn, Parkgate. This building has been included for its prominent position in the streetscape highlighted by the use of brick and stone detailing especially at ground floor level. The choice of varied window openings: Venetian windows to the top floor, sashes to the first floor and rounded arched window and door openings, shapely gables with ball finials and tall chimneys are also characteristic of the area.

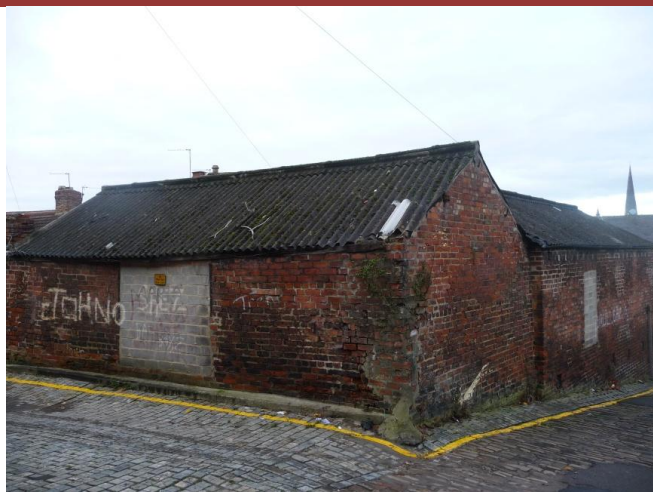
Former barn? This small group of red brick buildings sit on the back lane between Hargreave Terrace and Pensbury Street. They have an agricultural character and do not seem to belong to the surrounding terraced housing. An isolated building, possibly a barn is shown at this location before the Low Park was developed and suggests that this building is at least mid 19th century and predates the surrounding housing. It is in poor condition and has lost its original roofing, but is nevertheless of historic and archaeological interest.

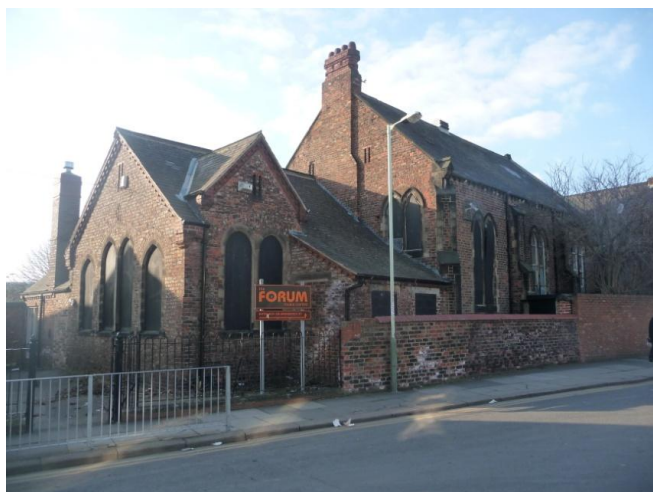
Former Brunswick Street Board School buildings, Brunswick Street/ Borough Road. This red brick former school building dating to 1871 with later additions is of local importance because it occupies a prominent position in the townscape and represents the only building left of historic character in Brunswick Street. Architecturally it has much in common with St Hilda's Church with tall lancet windows and with much of the wider area in its choice of brick with stone detailing. Also of architectural interest are the stone wall boundary features with gateposts – it is the sense of enclosure that this building brings which is now so lacking in Brunswick Street. Its other positive contribution is the pitched roofs and chimney which add to the interest of the street scene. The building has added group value because of its proximity to the red brick school/ nursery buildings next door on Borough Road with its lantern – another interesting addition to the roofscape.

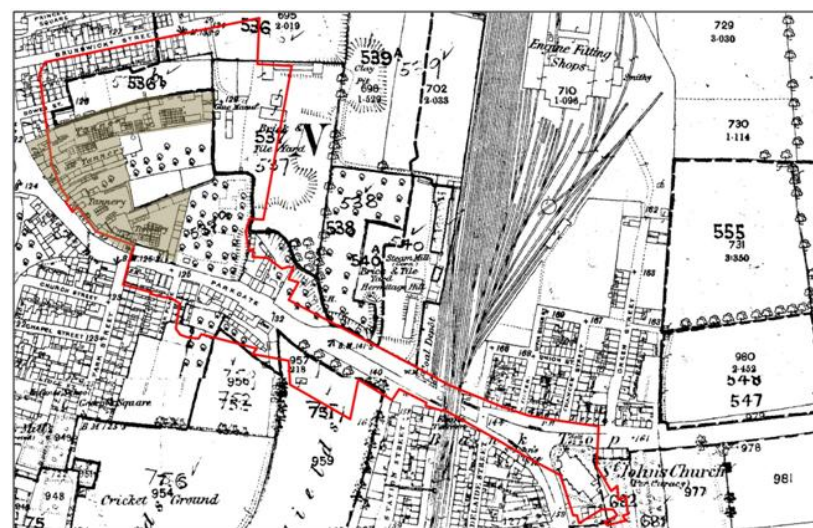
Figure 8. 1st ed OS map dating to 1856-65 showing the extent of tannery pits and buildings (and glue manufactory) in the area (shaded brown). Most of these are now located on the vacant plot next to the Cricketers. The red outline marks the extent of the conservation area.

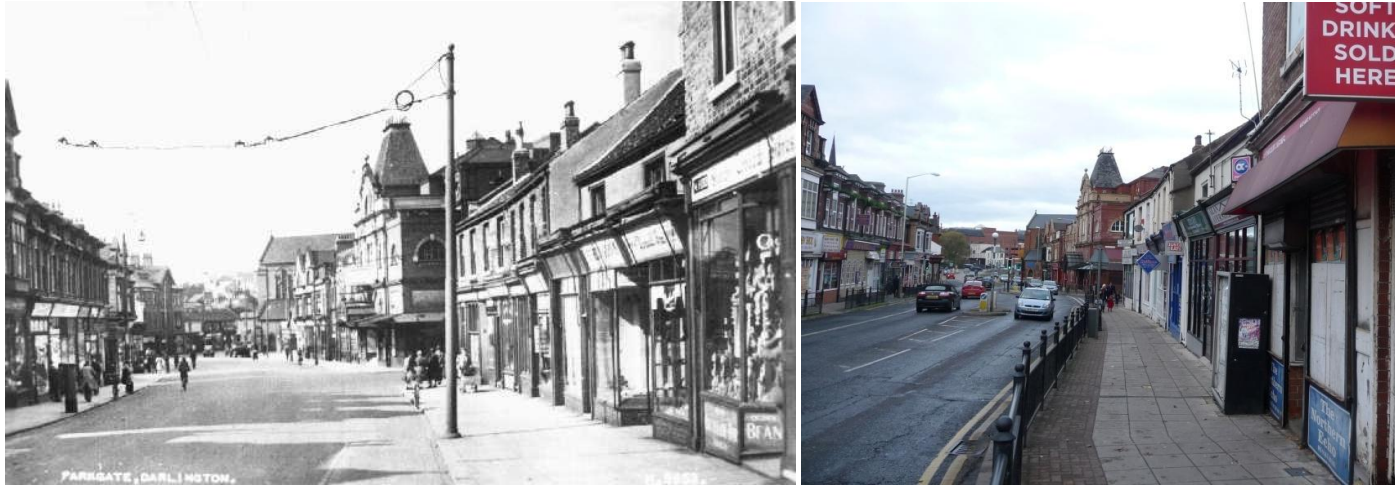
Plate 19. The most significant changes to Parkgate have arisen as a result of poor maintenance of shop fronts, inappropriate replacement windows and heavy traffic, however some of this is reversible and historic character can be restored through the provision of renovated shop fronts and traditional windows and doors. Left photo dates to 1951.

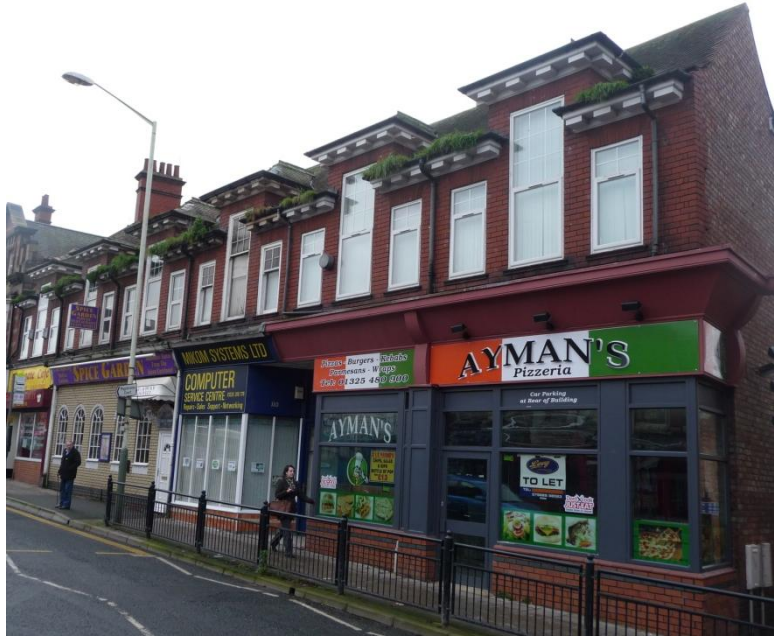
Plate 20. This building displays a number of management issues. Grass is growing from the gutters, a shop front has been reclad in inappropriate materials which along with garish and overly large fascias breaks up the unity of design at ground floor level

- Better maintenance of properties needs to be carried out to prevent more expensive remedial works at a later date.
- Shop owners may require some advice to help conserve or restore their traditional shop fronts and to reverse some of the damage caused by inappropriate cladding and large fascias.

- Home owners need advice on the potential damage caused by concrete cladding and pebble dash. Advice on improving thermal efficiency without damaging the historic character may be beneficial.

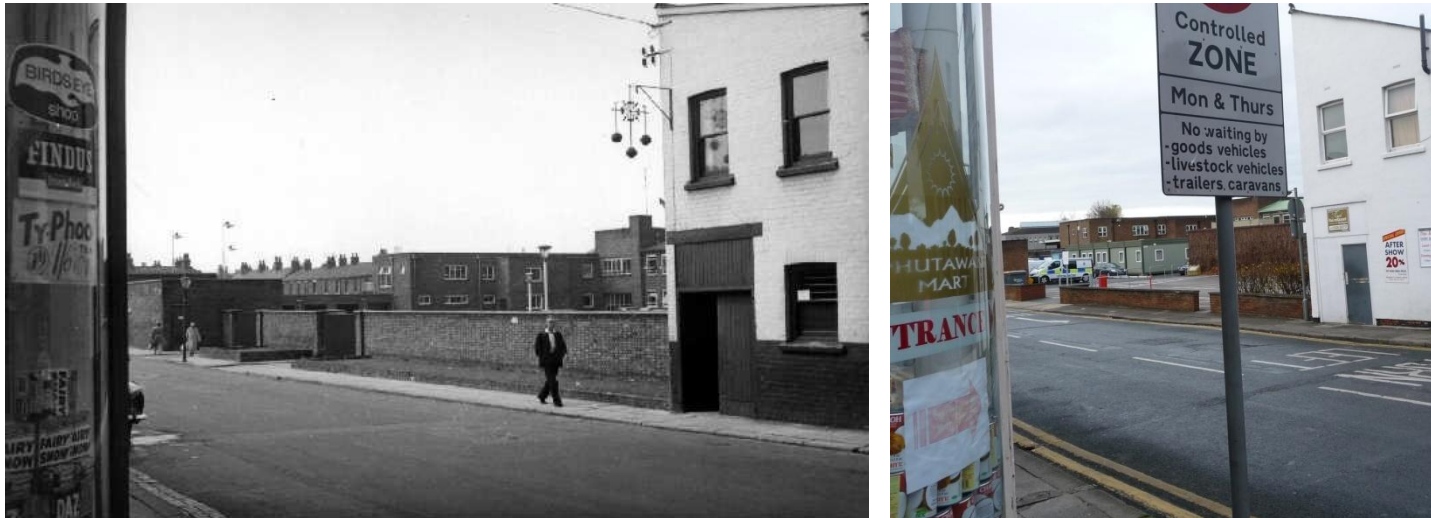
Plate 21. Surprisingly little has changed here since the late 1960s except the growth of street signs. However such open spaces have the potential to be redeveloped in the future with high quality high density development which makes a positive contribution to local character and distinctiveness

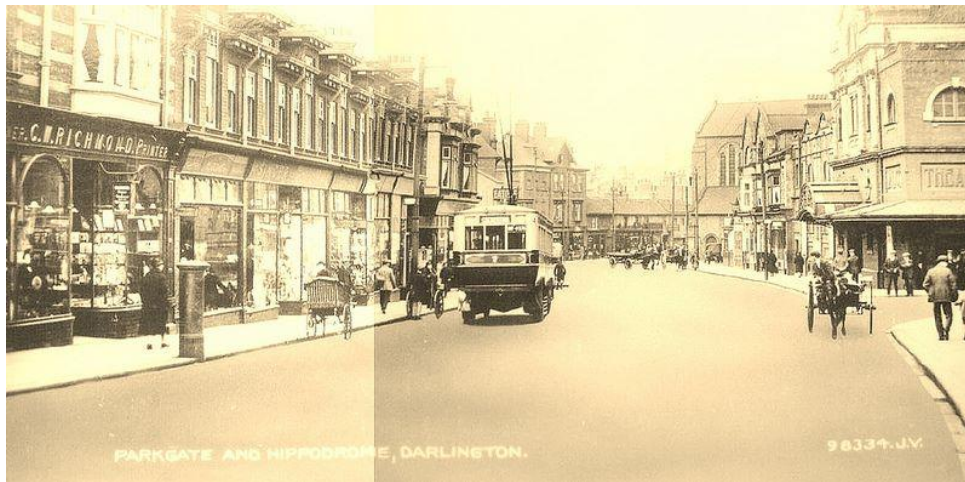
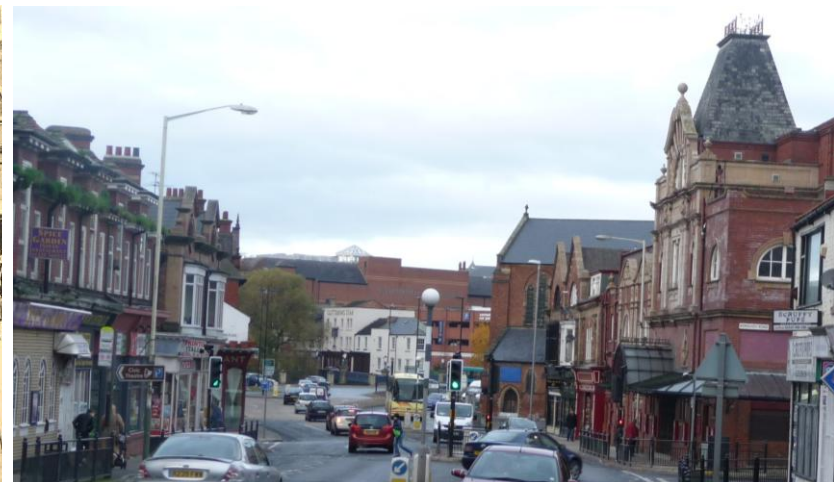
Plate 22. Left: This busy street scene of Parkgate in its Edwardian heyday shows how the loss of buildings at the south end of Parkgate have since been replaced with a busy corridor of traffic which has divorced it from the town. Future development should seek to make better connections with the town centre by taking development up to the ring road and avoiding barren open spaces (image courtesy of Chris Lloyd of the Northern Echo). Plate 23. Right: Although some attempt has been made to break up the roofline of the Cornmill centre, its scale, massing and large flat area obstructs views of any roofscape beyond and adds a visual barrier between Parkgate and the town centre. Future development should make a positive contribution to the roofscape, but not obstruct views of the existing varied rooflines.

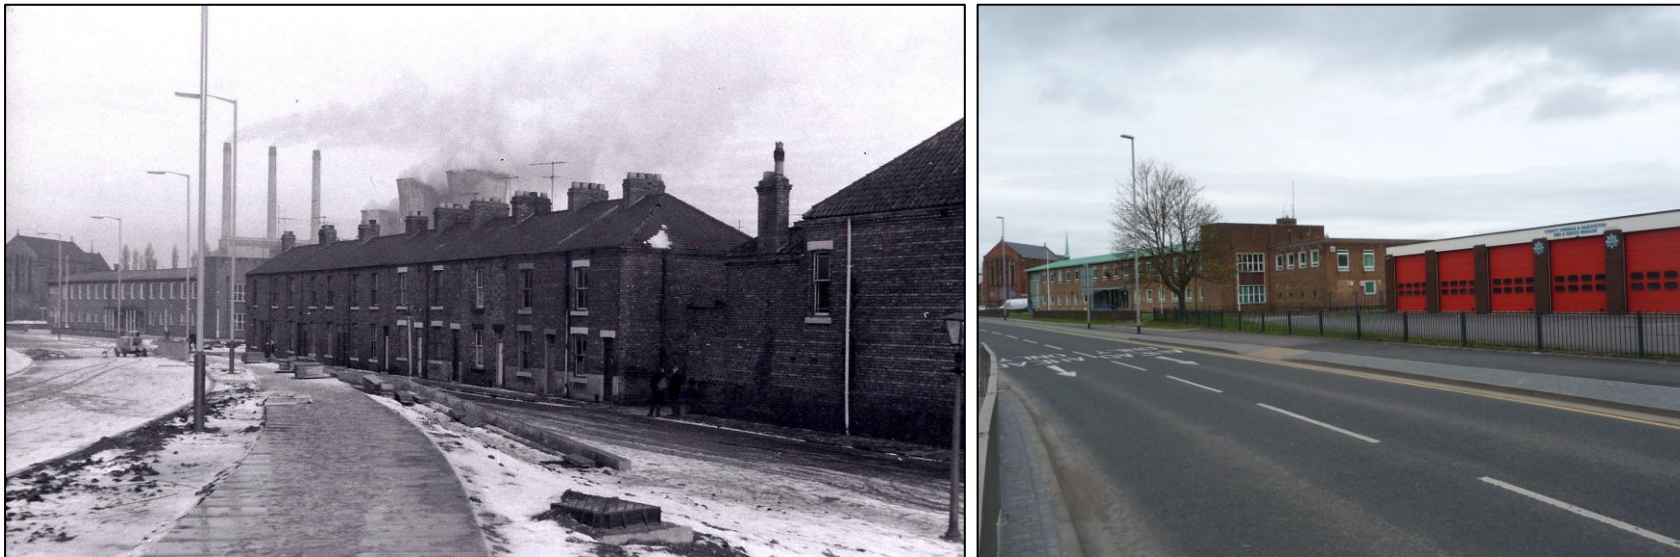
Plate 24. Left: This image dating to 1968 shows the works to create the ring road and the new police station, with existing street frontage housing due to be demolished where the fire station is now (image courtesy of Chris Lloyd of the Northern Echo). Right: Unfortunately, the open spaces and modern buildings which replaced the terraced housing are devoid of character and further emphasise the separation of Parkgate from the town centre
