Parkgate Conservation Area Character Appraisal

For Darlington Borough Council

April 2015

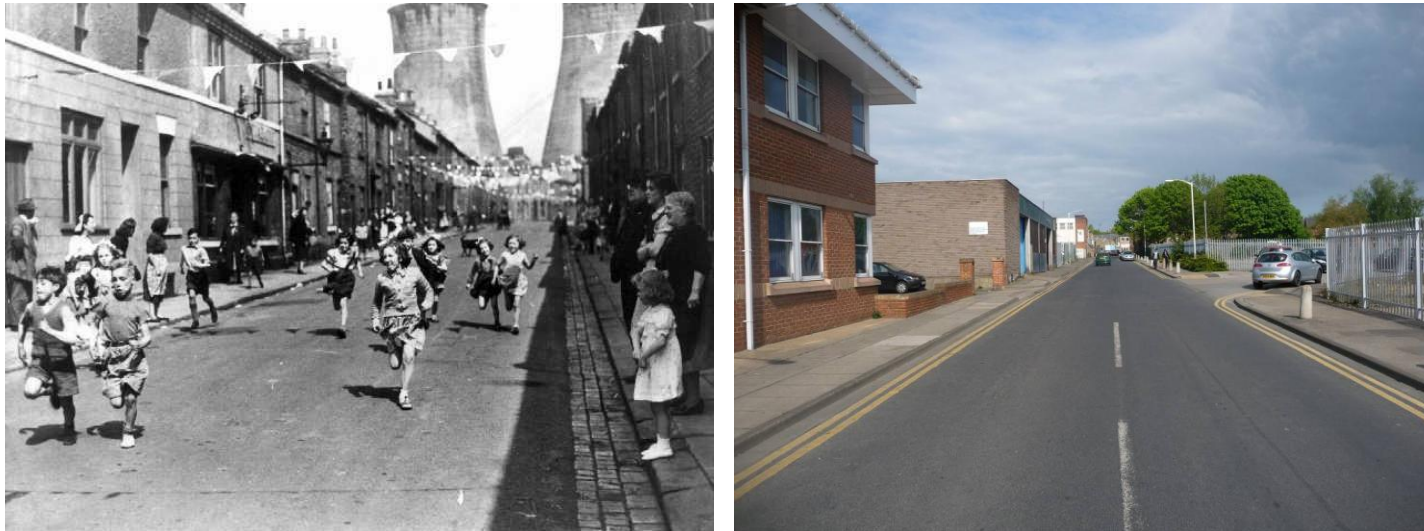
Plate 21. Brunswick Street: the loss of the cooling towers is not regrettable, but the loss of the terraced houses has also resulted in a loss of community. The redevelopment of this land offers an opportunity to enhance the conservation area.
