The 1825 Stockton & Darlington Railway: Historic Environment Audit

Appendix 1. Witton Park to St Helen Auckland.

October 2016 (2019 revision)

Archaeo-Environment for Durham
County Council, Darlington
Borough Council and Stockton
Council.

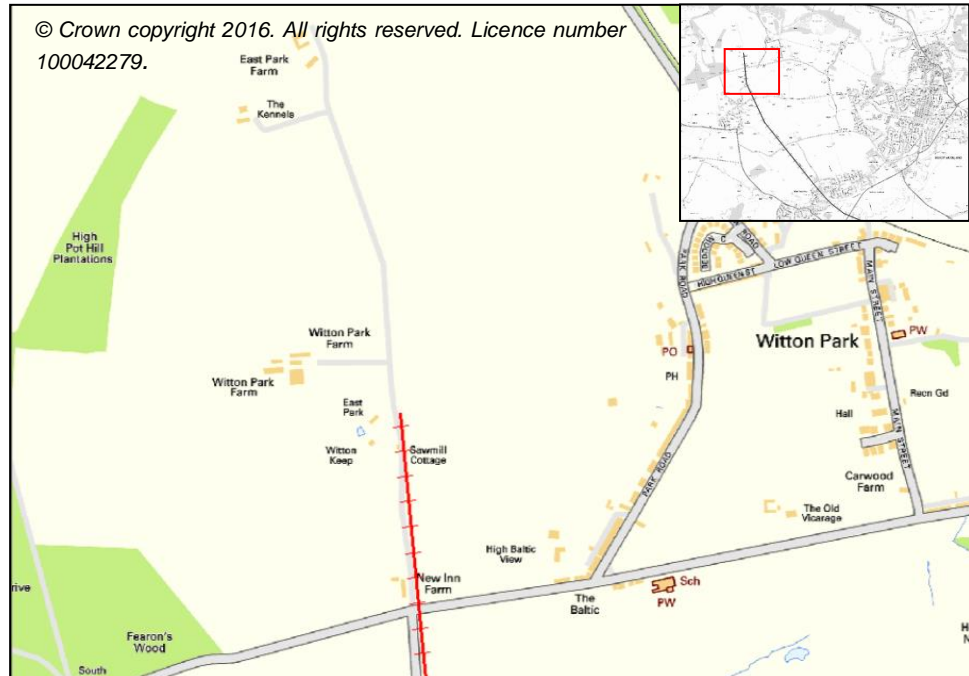
Figure 3. The head of the line where colliery wagons were assembled and led to the start of the Etherley Incline.

The possible remains of the 1825 track bed near the entrance to Witton Keep should be the subject of a small scale trial excavation to test if this identification is accurate.

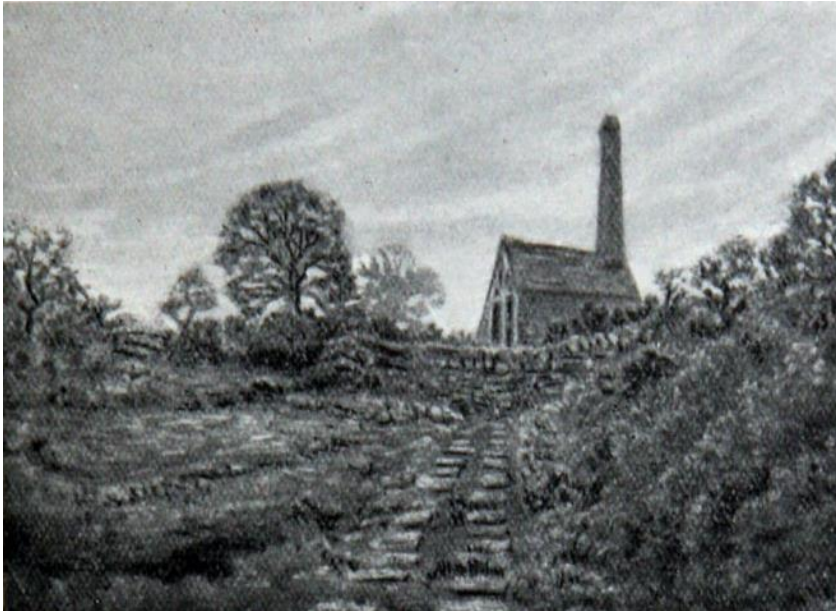
A short distance south of Low Etherley are a row of 18 pairs of sleeper stones. Set very close together these are not likely to be in their original position (SDR54 & 55). On the east side of the incline before the Engine House, there is a large rectangular boggy area (SDR60). Visible on the 1st edition OS it appears related to the incline but has no obvious function. It may have been a water collection point from the incline drainage.

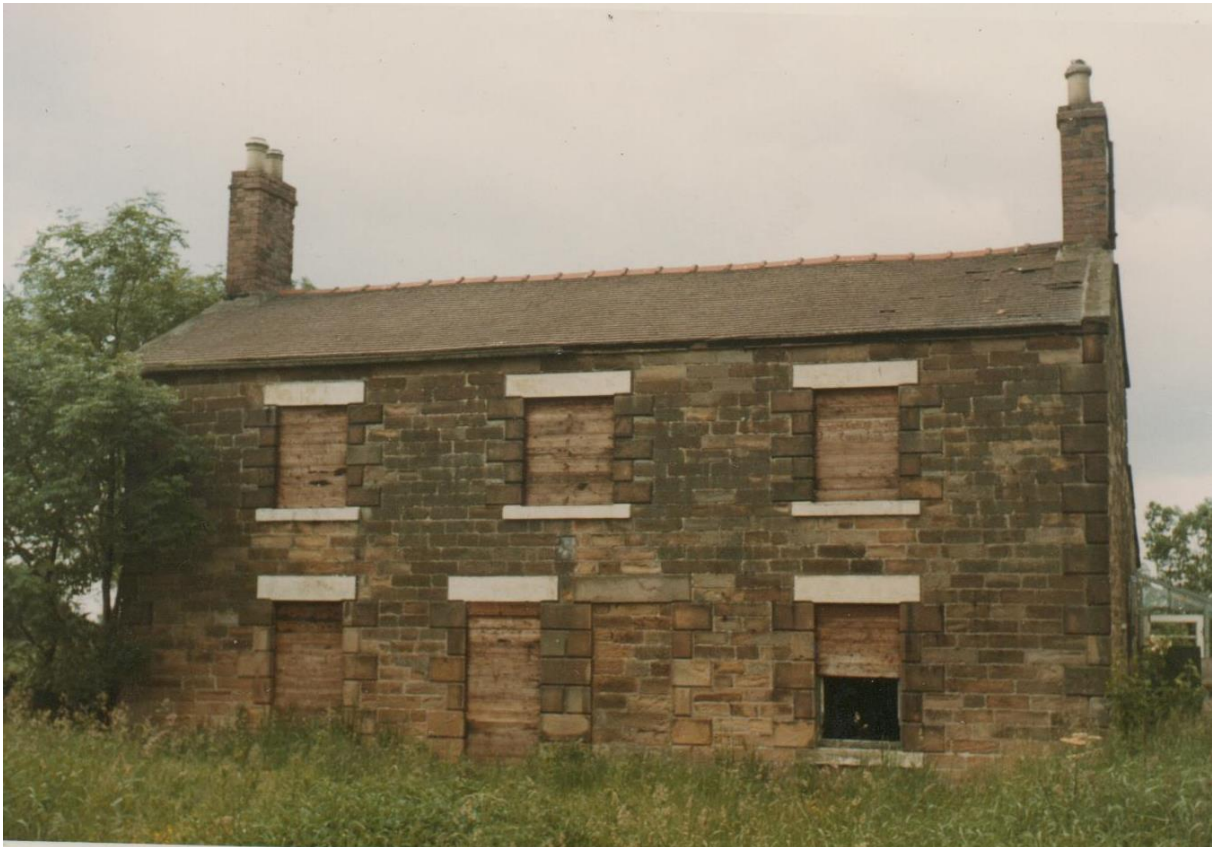
Plate 7. The Engineman's House, shortly before demolition. Originally two cottages, It had two doors to the front (right hand now blocked); one for the engineman and one for the blacksmith, although latterly it was simply rented out as domestic accommodation.

At the top of the incline and included in the scheduled monument is the site of a group of buildings and structures. The Engineman's House (SDR506) was demolished in the 1980s despite local opposition. The Engine House has been demolished for considerably longer, but architectural fragments of the building survive in adjacent boundary walls (SDR68). There is good documentary evidence about the first two Enginemen at Etherley (the Greeners), and the form and appearance of the Engineman's House (and adjacent blacksmith's house). Information even extends to the interior design of the engineman's house (Greener 1885).

The dry stone wall boundary walls around the Etherley Engine house site are in poor condition and so the architectural fragments are vulnerable. Some consolidation is required.

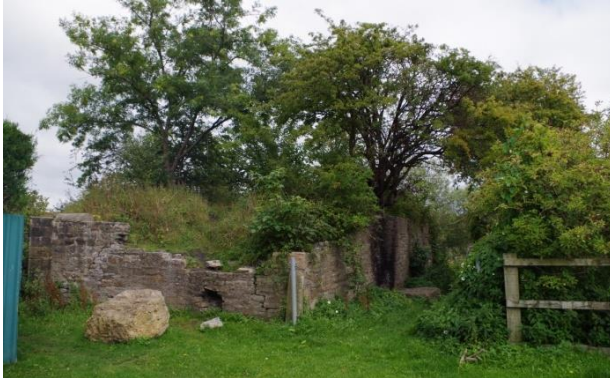
Plate 20. (below) The Gaunless Bridge looking south-east. Prior to 1901 (bottom left), and today (bottom right), partially dismantled, vandalised and covered in graffiti. This is a Scheduled Monument and one of the most important early buildings in railway history.

The south abutment of the Gaunless bridge is suffering from self-seeded vegetation which needs to be controlled. The un-managed bushes hide the ornate stonework of the bridge abutment and its sweeping wing wall with string coursing and rounded pillar terminus so that it cannot be appreciated and the self-seeded trees on top of the abutment will be causing root damage. Self-seeded vegetation also disconnects the visual links between the bridge abutments and the accommodation bridge.
-

The iron structure from the Gaunless Bridge should be moved from NRM York to NRM Locomotion at Shildon for display. The bridge was designed to be free standing which might make it easier to display. It should not be replaced on the abutments as it would be at risk from vandalism and the abutments were modified in 1901 so the original decking would no longer fit.
