The 1825 Stockton & Darlington Railway: Historic Environment Audit

Appendix 2. West Auckland to Shildon.

October 2016 (2019 revision)

Archaeo-Environment for Durham
County Council, Darlington
Borough Council and Stockton
Council.

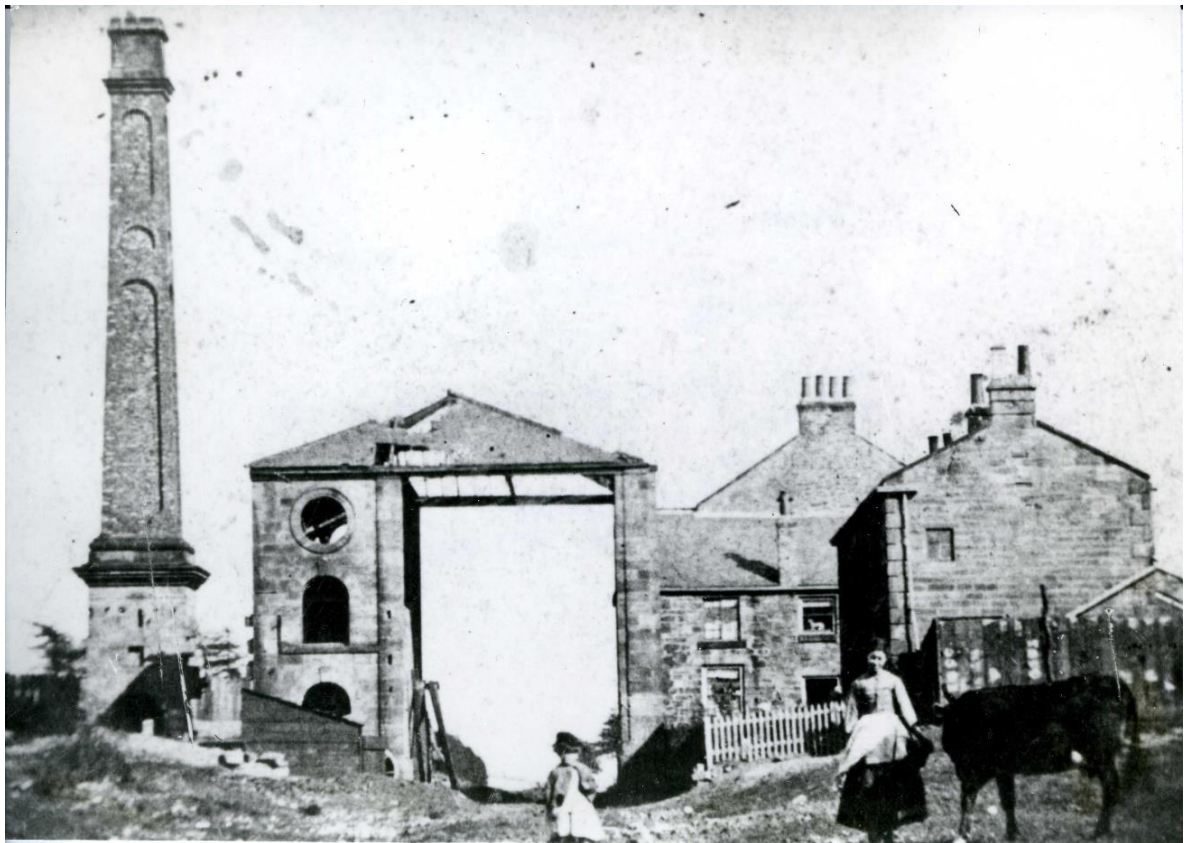
He replaced the engine in 1831 with a more powerful, 80 horse power one built by R & W. Hawthorn of Newcastle. This engine could haul six sets of waggons an hour which was a considerable improvement (Young 1975, 133). Due to their large size, the new engine house and chimney had to be sited on the north side of the track. The drum house spanned the track, linking the new engine house with the original one.

Plate 14. The second engine house at Brusselton built in 1831

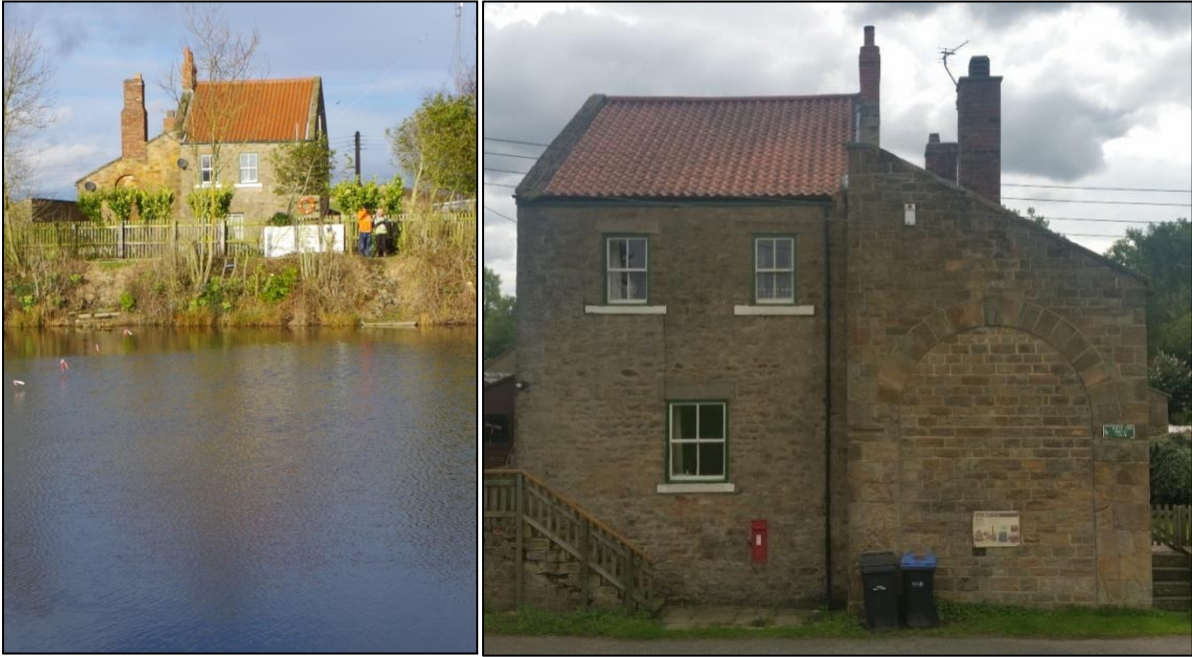
Plate 15. The Engine House seen from the south across the reservoir (above left), and from the north (above right)

The tall garden walls around the Engine House incorporate the remains of a number of split sleeper stones (SDR115). To the rear of the Engine House the reservoir which provided water for the steam engine survives intact, but is not legally protected (other than being in a conservation area). Some of the reservoir retaining walls also include split sleeper stones, suggesting an original earth embankment was subsequently repaired and retained with stonework.

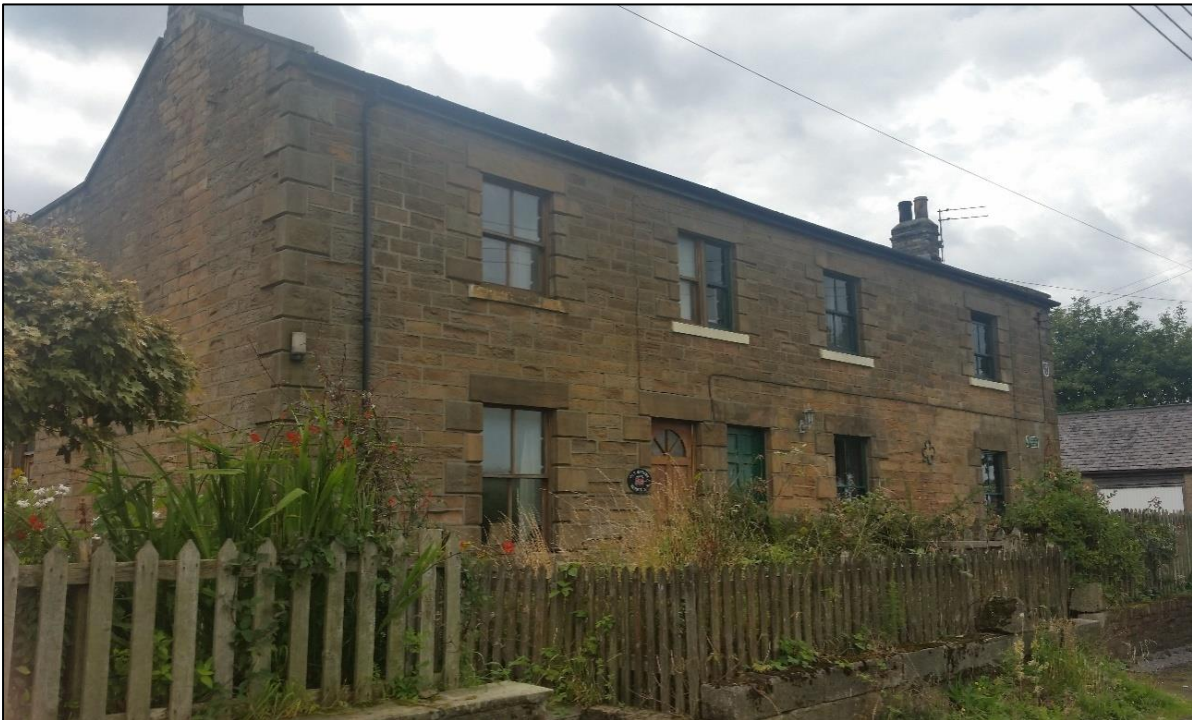
Plate 16. The engineman's house with the blacksmith's house (?) adjacent from the north

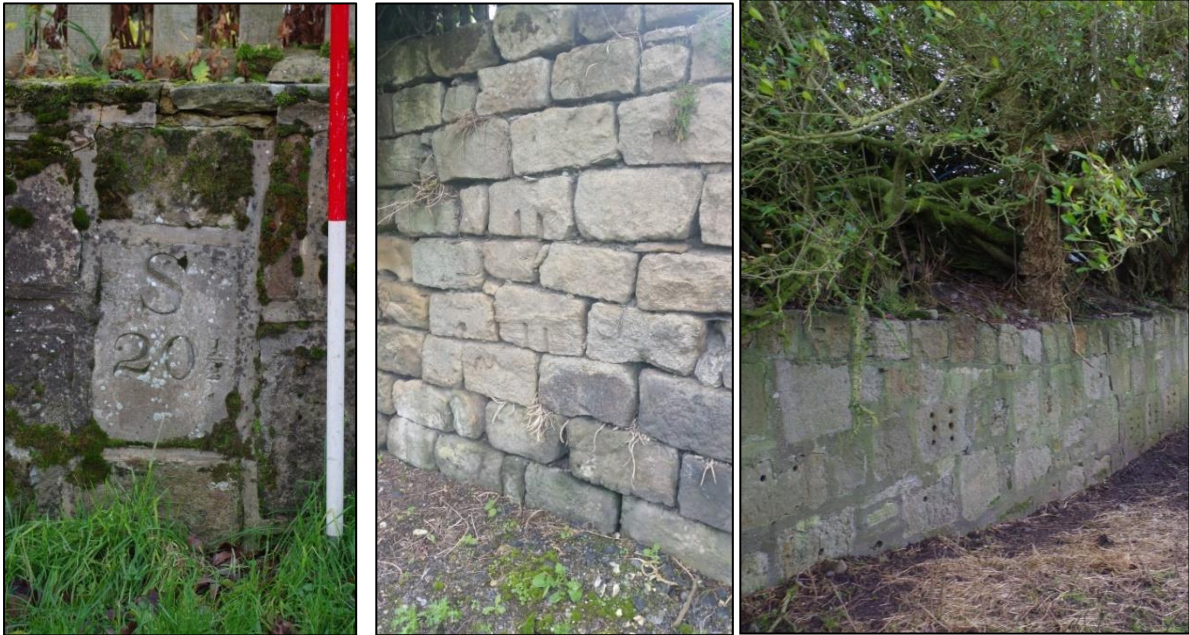
An S&DR milepost (SDR102) has been inserted into the dwarf garden wall of the Engineman's House, which marks 20 ½ miles from Stockton. Although not in its original position, it is in the right area because it is about that distance to Stockton from here.

Plate 17. (Left): The S&DR Milestone marking 20 ½ miles to Stockton and now incorporated into a garden wall of the Engineman's House. (Centre): split stone sleepers reused in the garden wall of the Engine House. (Right): the walls of the reservoir which also incorporate split sleeper blocks.
