# VERIFICATION REQUIREMENTS FOR GAS PROTECTION SYSTEMS

Technical Guidance for  
Developers,  
Landowners and  
Consultants

Yorkshire and Lincolnshire  
Pollution Advisory Group

Version 1.1 – December 2016

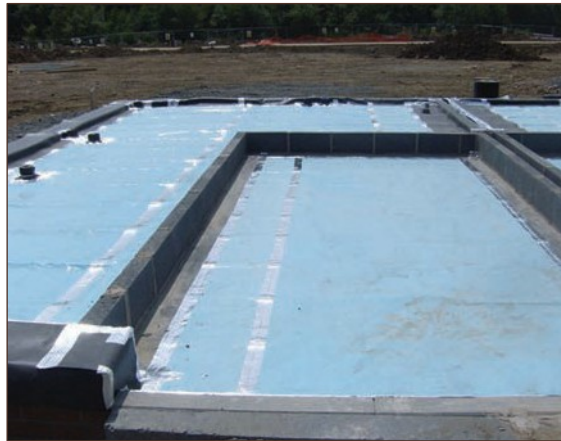
**Figure A4.10** Almost complete coverage available for inspection, minimal jointing, service entries suitable distance from walls, light traffic (courtesy Smith Grant)

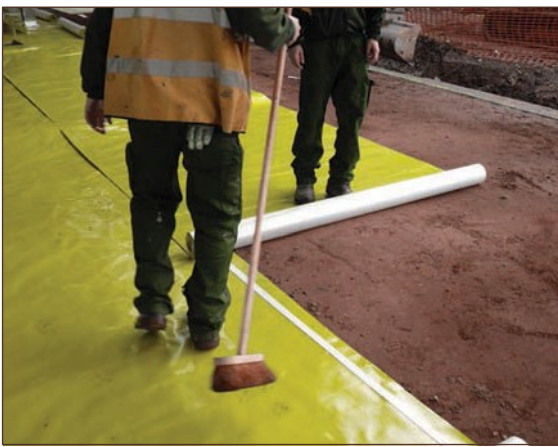
**Figure A4.15** LDPE type gas membrane overlap and double sided tape. Sand blinding to protect underside of gas membrane (courtesy A Proctor Group)

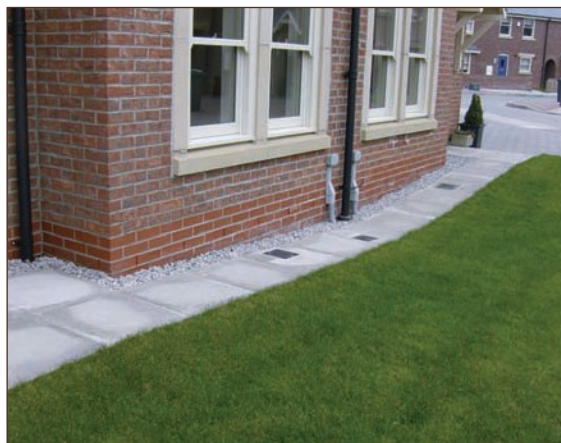
**Figure A4.36** Raised air bricks are preferable due to the reduced potential for blockade but the vent trench specified is provided with clean single sized stone (courtesy Smith Grant)

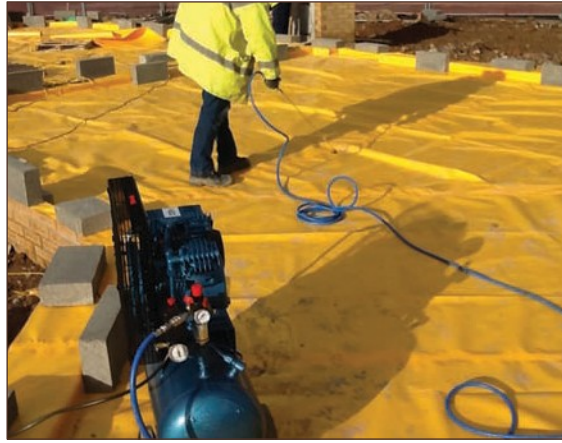
Figure A4.44 Air lance test, used to test the quality of welded seams along gas membrane joints (courtesy MEC Environmental Ltd)

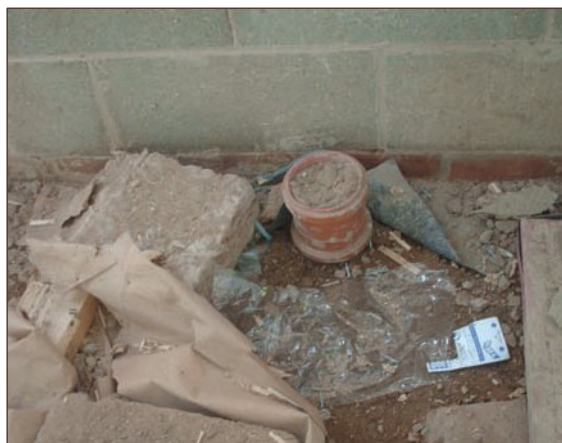
Figure A4.48 Loose nails and over construction debris likely to be left in place beneath gas membrane – poor preparation of gas membrane prior to sealing service penetration (courtesy Card Geotechnics Limited)

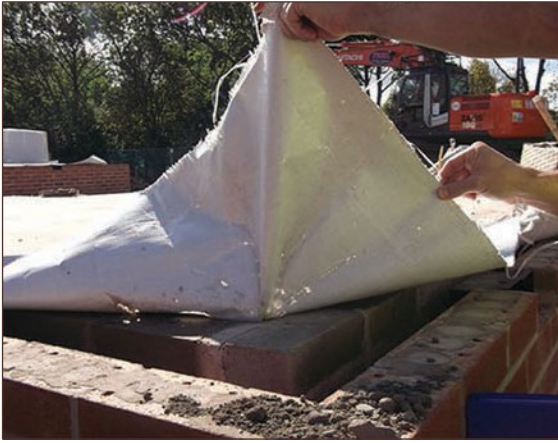
**Figure A4.49** *Lifted gas membrane at corner position. Light penetrating through confirms damage to aluminium internal core layer (courtesy NHBC)*

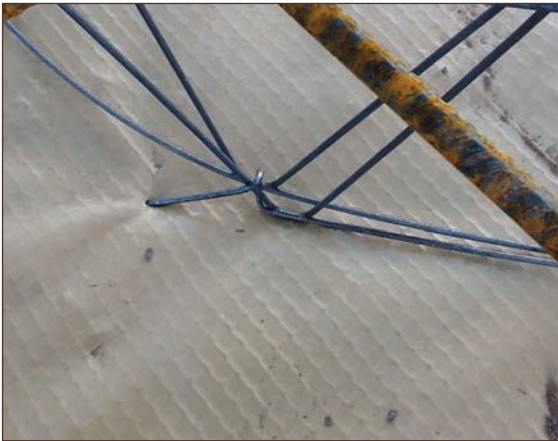
**Figure A4.51** *Gas membrane torn by reinforcement (courtesy MEC Environmental Ltd)*

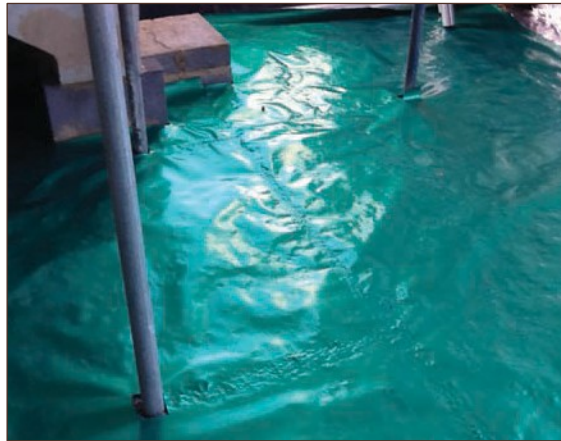
**Figure A4.52** *Gas membrane cut by scaffolders and bricklayers after installation (courtesy MEC Environmental Ltd)*

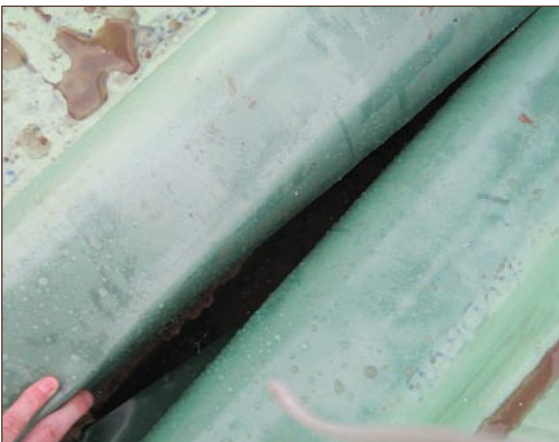
**Figure A4.59** Gas membrane slit at the bottom of a cavity tray to enable water to drain away (courtesy Smith Grant)

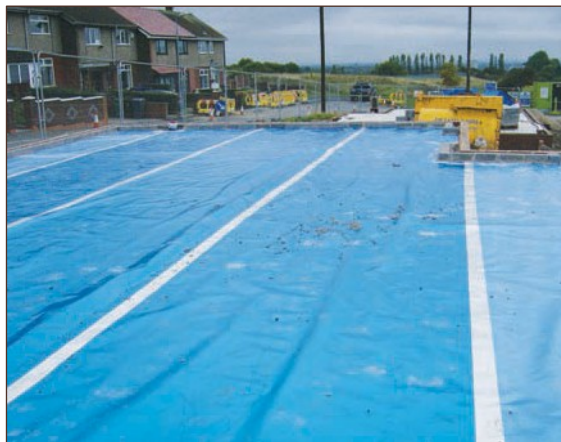
**Figure A4.60** Some stones could penetrate gas membrane if sufficient force is applied (courtesy Smith Grant)

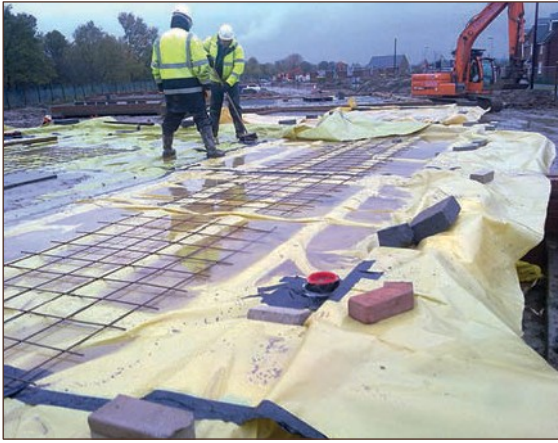
**Figure A4.67** Traffic over mesh resulted in several punctures, in addition most joints were found to be poorly constructed. Taped joints are difficult to construct in adverse weather (courtesy Smith Grant)

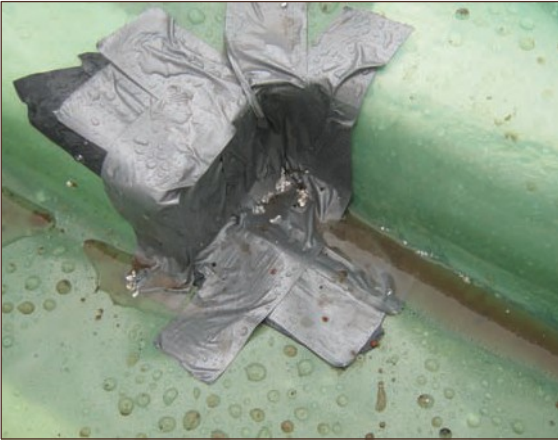
**Figure A4.69** Attempt at corner detailing using non-proprietary duct tape (courtesy Smith Grant)

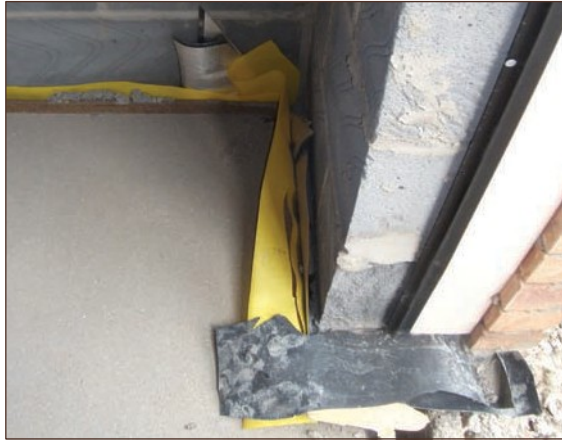
**Figure A4.70** Inadequate corner detailing. The use of preformed proprietary products would have avoided such bad practice (courtesy NHBC)

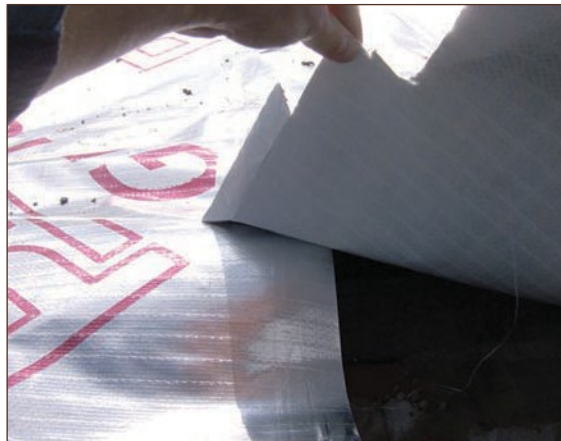
**Figure A4.76** No double sided tape used in joints (courtesy Smith Grant)

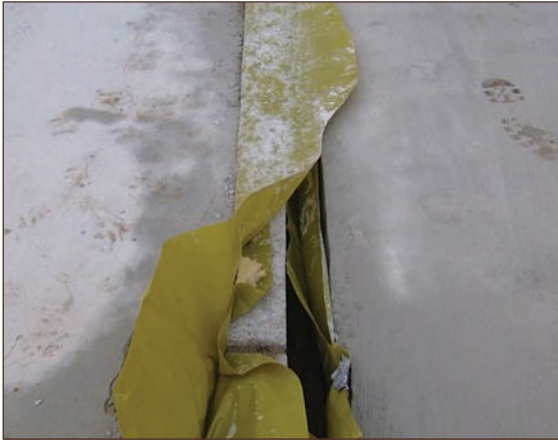
**Figure A4.79** Gas membrane not continuous over internal wall. It had been deliberately cut open for unknown purpose (courtesy Smith Grant)

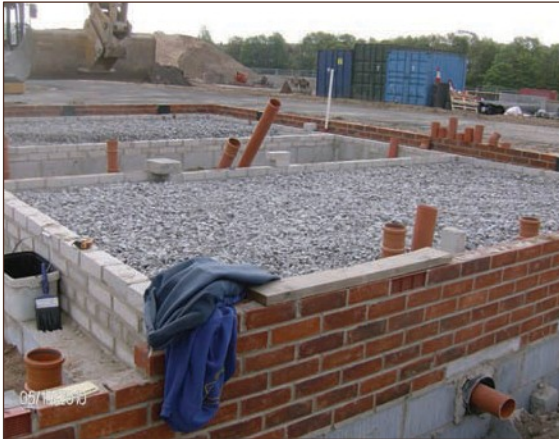
**Figure A4.85** Clean single sized stones with no fines acting as venting media, however no ventilation gaps in internal sleeper walls (courtesy Smith Grant)
