1. Introduction

West End Conservation Area (formerly known as Stanhope / Grange Road Conservation Area) was designated in 1975 and enlarged in 1990 and 1999. Featuring the best of Darlington's early suburban development from the 18th to 20th Century, this Conservation Area has a varied character that provides instructive forms for future suburban development as well as its own intrinsic value.

3. Summary of Special Interest

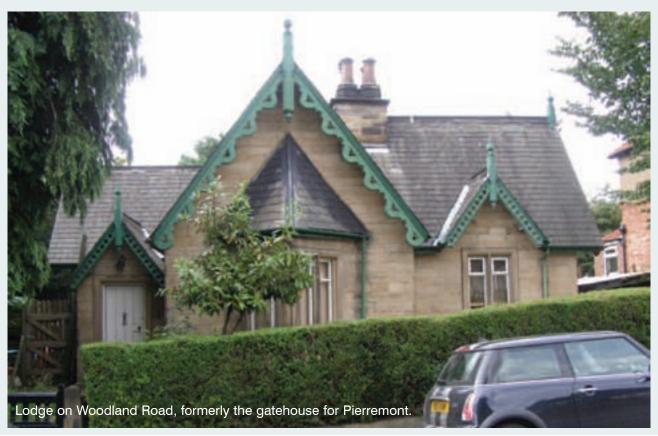
Evidence on the ground still exists of the boundaries to these properties in the form of substantial stone walls and gate piers, either still in use for larger infill properties or now defunct and stopped up. In the case of Southend, part of the grounds now form a linear park alongside Grange Road.

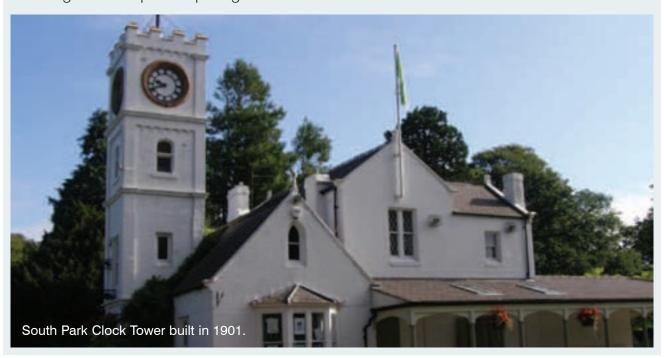
South Park

Within the park various buildings were provided including the clock tower (1901) and the tea pavilion (1908). The Listed bandstand was built in 1893 (at a cost of £250 from skater's fees) and the fountain from Pierremont was relocated from it's original home in the grounds of the villa.

The Fothergill Fountain is next to the Parkside entrance after being moved from its former home in Bondgate. John Fothergill was a key member of the temperance movement.

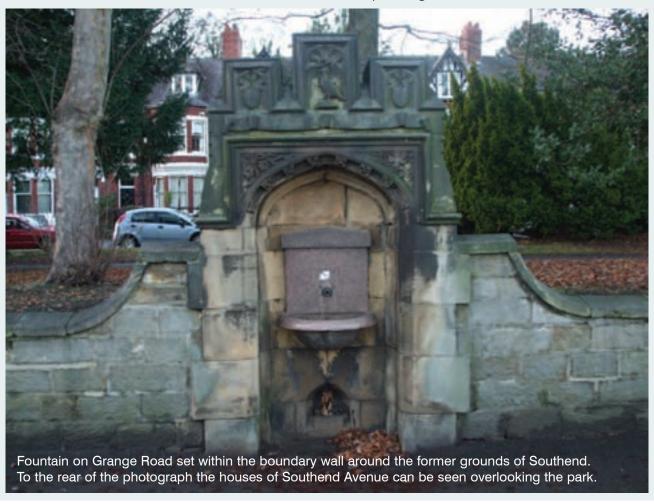
Also in 1866, Joseph Pease donated this fountain on Grange Road. Of carved stone with Granite bowl, bird motif and shields to either side. In good condition, not connected to the water supply.

These fountains were gifted by Quaker patrons with the aim of promoting temperance whilst providing refreshment to the passing traveller.

The drinking fountains are currently not used and are under threat from decay and neglect in some cases.
